Survey Report

Surveys Along Neches River
about 21 mi. N. 88° E. of Athens

THE NECHES RIVER IN THE BIG EDDY LAKE AREA

HENDERSON ~~SMITH~~ AND SMITH ~~ON~~ COUNTIES, TEXAS

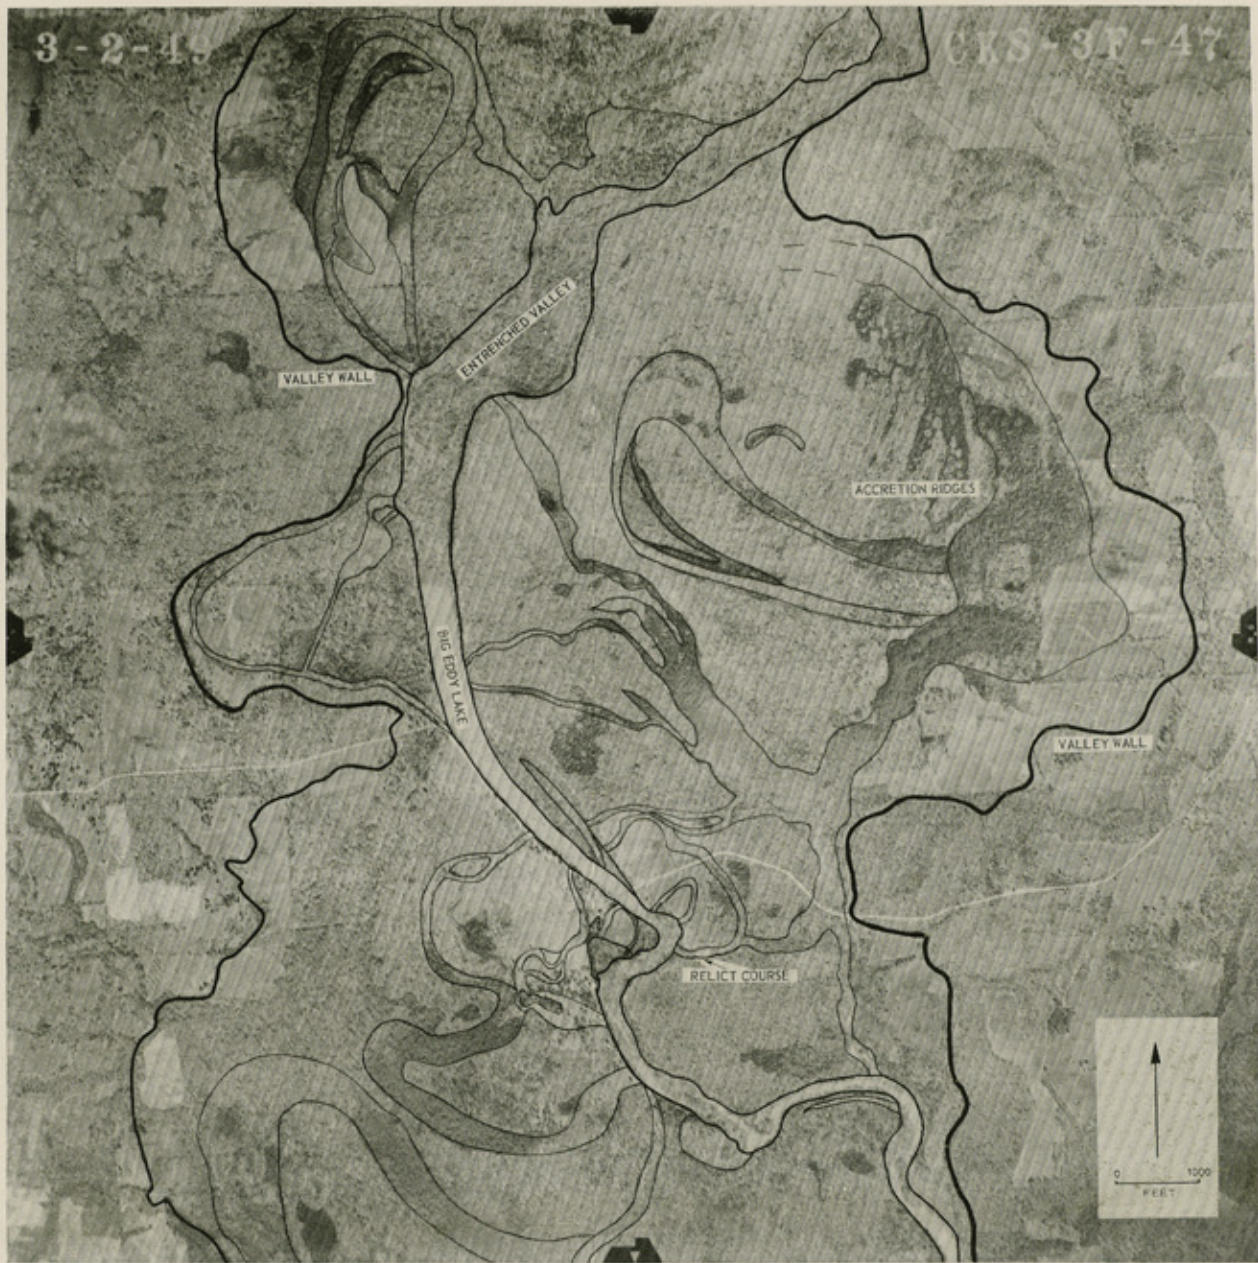
Figure 2. Airphoto showing the Big Eddy Lake area. Lines have been added to delineate some of the physiographic features.

As seen on the airphoto, figure 2, the Neches River has meandered back and forth between the valley walls. Traces of these relict courses can, in some cases, be followed for considerable distances; in other cases, only isolated meander scars can be seen. Their progressive development is shown by accretion ridges and their courses are partially outlined by low natural levees.

The recent behavior of the Neches River is controlled by events that took place several hundred years ago. These events resulted in the confinement of the river to a relatively narrow (200 to 800 feet) entrenched valley and eventually in the formation of Big Eddy Lake. In the discussion which follows it is necessary to differentiate between the alluvial valley of the Neches River and the much smaller entrenched portion within this valley. The alluvial valley is the area averaging about one and one-half miles wide, lying between the valley walls (figures 1 and 2); the entrenched valley (figure 2) is cut into the larger valley and is marked by low scarps on both sides of the present river.

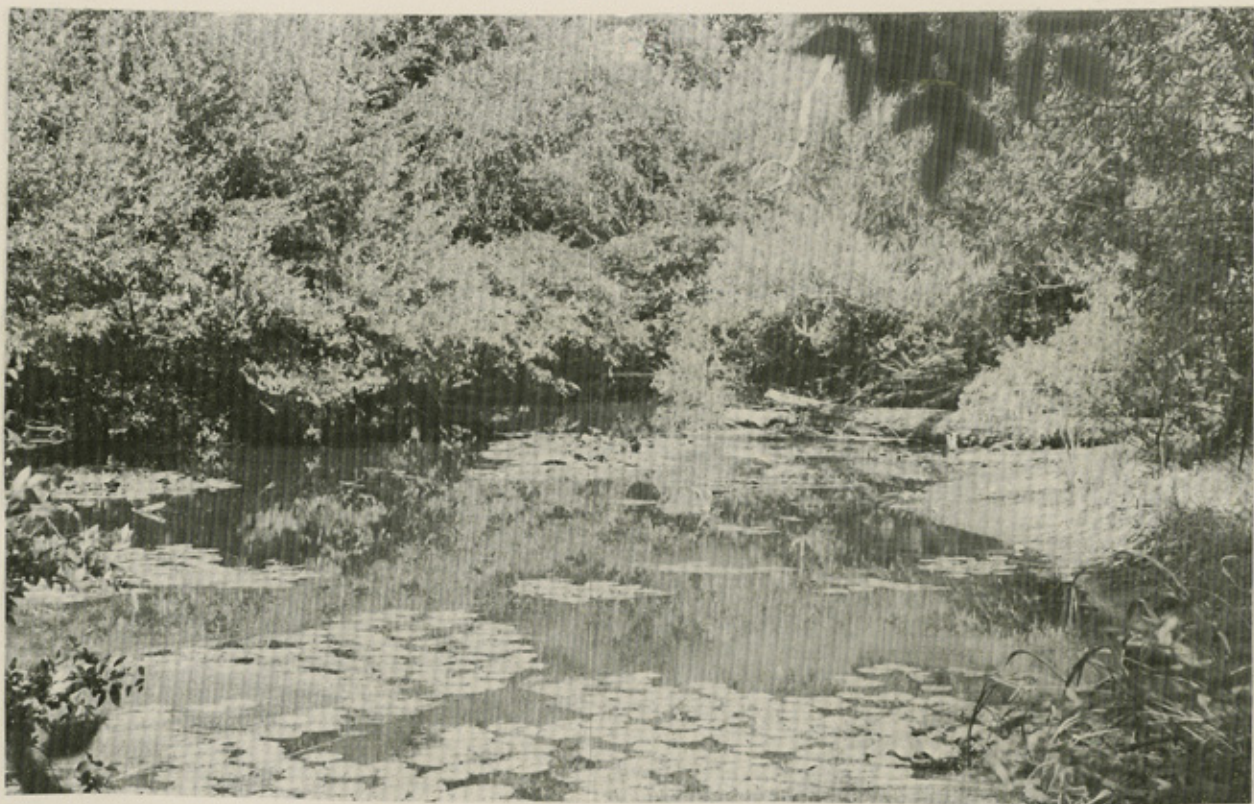
Figure 8. Detail of clogged channel at south end of lake.

lake, particularly during high water stages, blocking the existing channels and forcing the river to flow along new courses. In effect, this entire half-mile is the dam which is responsible for Big Eddy Lake (figure 8).

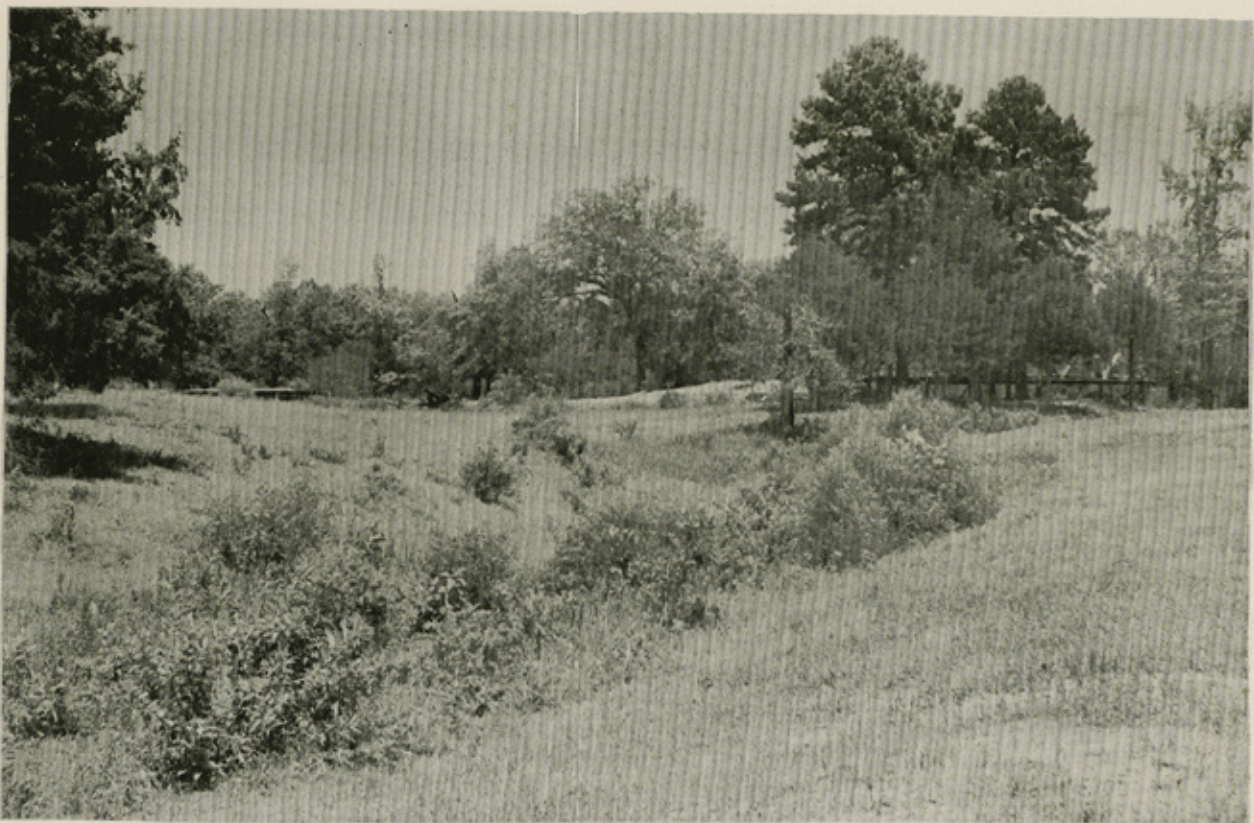
Figure 9. View of relict course looking east toward Big Eddy Lake. This "slough" probably occupied by river during flood stage of March 1901.

The survey of the tract just north of this one, made in March 1901, calls to follow the meanders of the river for a short segment of its course. At the position called for by the surveyor's notes there is now a "slough" (point "B" on the photo, figure 4). This slough (figure 9) could not have been the main channel of the river during the time of the survey; it is a portion of a relict course which, although probably younger than many of the larger relict courses of the valley proper, is much older than the entrenched valley. Both ends of this course are cut by the sharp bend of the modern river.

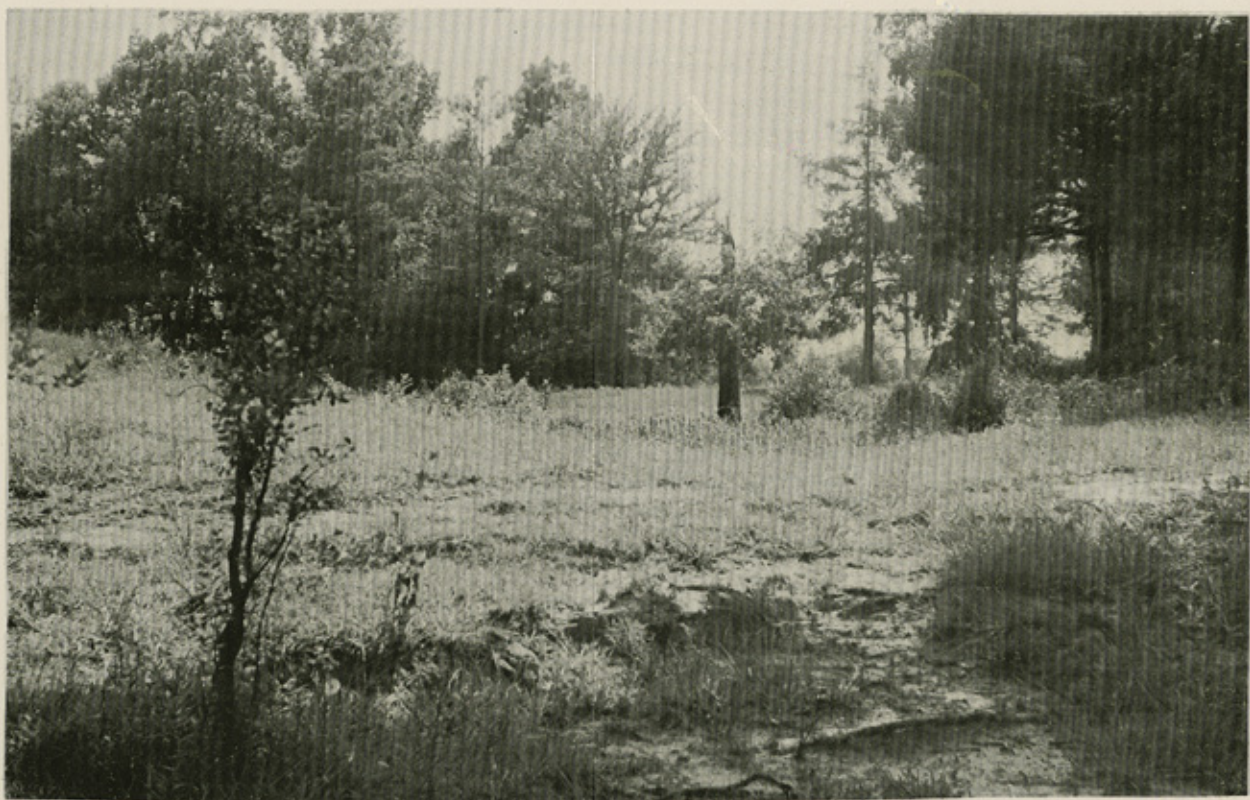
Figure 10. View of same relict course as figure 9 but looking west from surface of Big Eddy Lake.

When the river is in extreme flood stage, most of the relict courses are under water. Even at a much lower flood stage, the course shown at "B" is probably kept open by waters flowing through it. It may even have been lowered somewhat from its original level by erosive action. Its open upstream end (figure 10) is today only about five feet above the level of the lake.

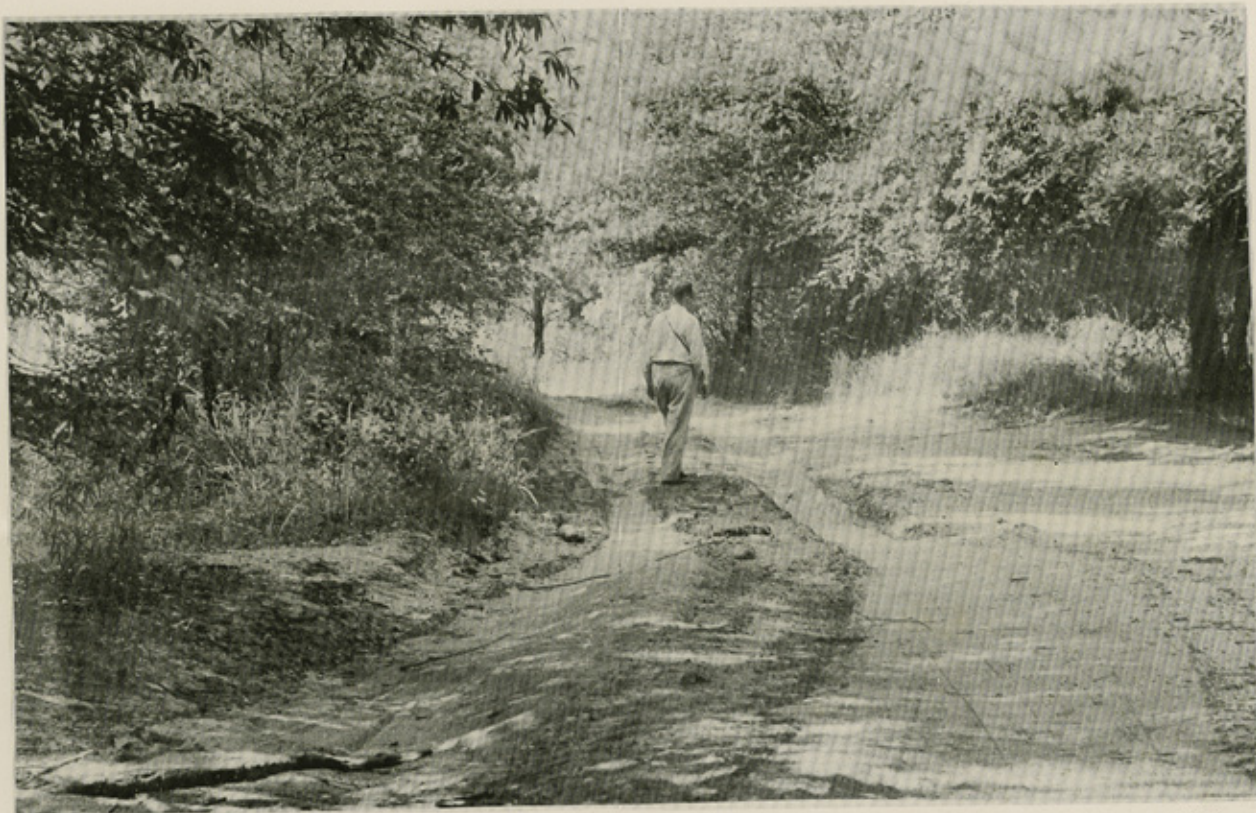
Figure 11. East-west portion of relict meander which may be associated with the formation of Big Eddy Lake.

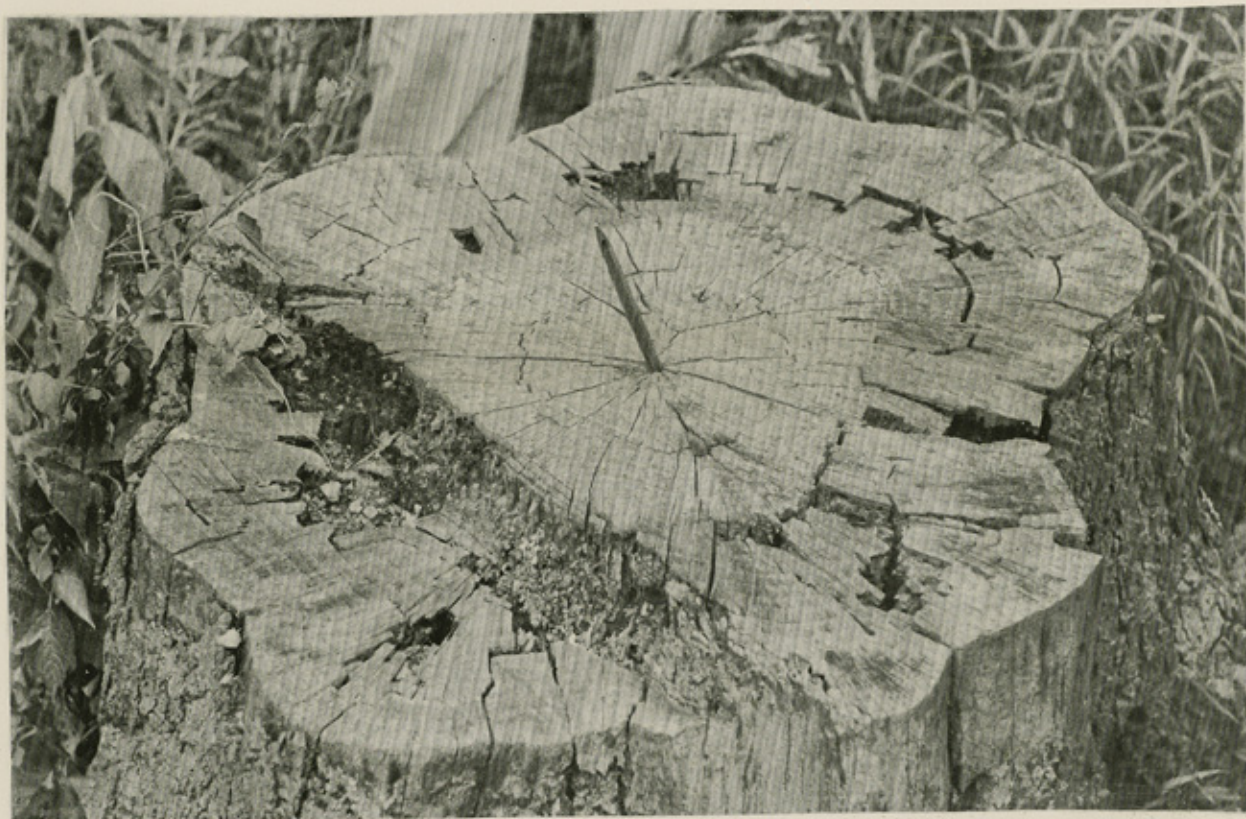
Figure 12. Tree stump in entrenched valley at south end of Big Eddy Lake.

There is some evidence, other than geological, which also suggests that the entrenched valley is old. The entire bottom area is heavily wooded with trees that can withstand a certain amount of flooding. Overcup oaks nearly 100 years old (based upon ring counts on stumps) and large planer elms, willows, and sweet gum trees all attest to a minimum age of this trench (figure 12).

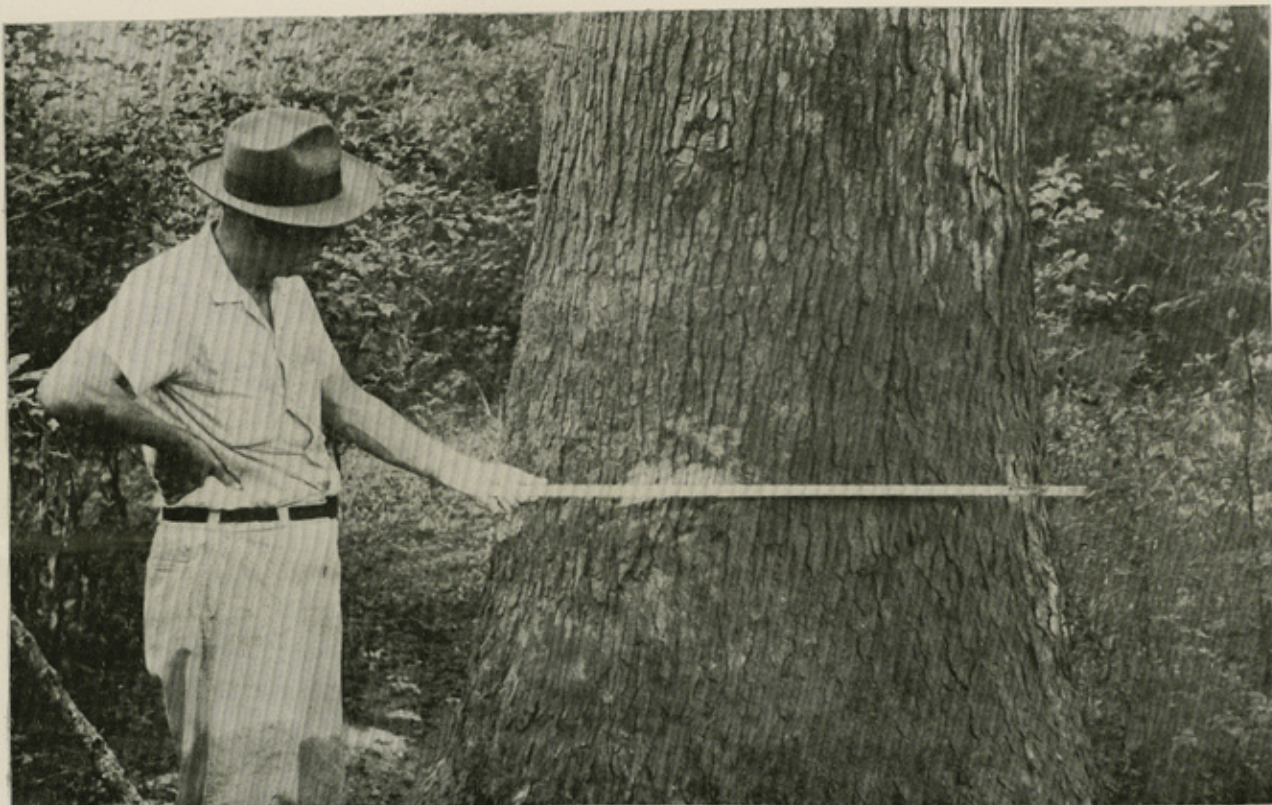
Figure 13. Gum tree in entrenched valley approximately 600 feet from head of Big Eddy Lake.

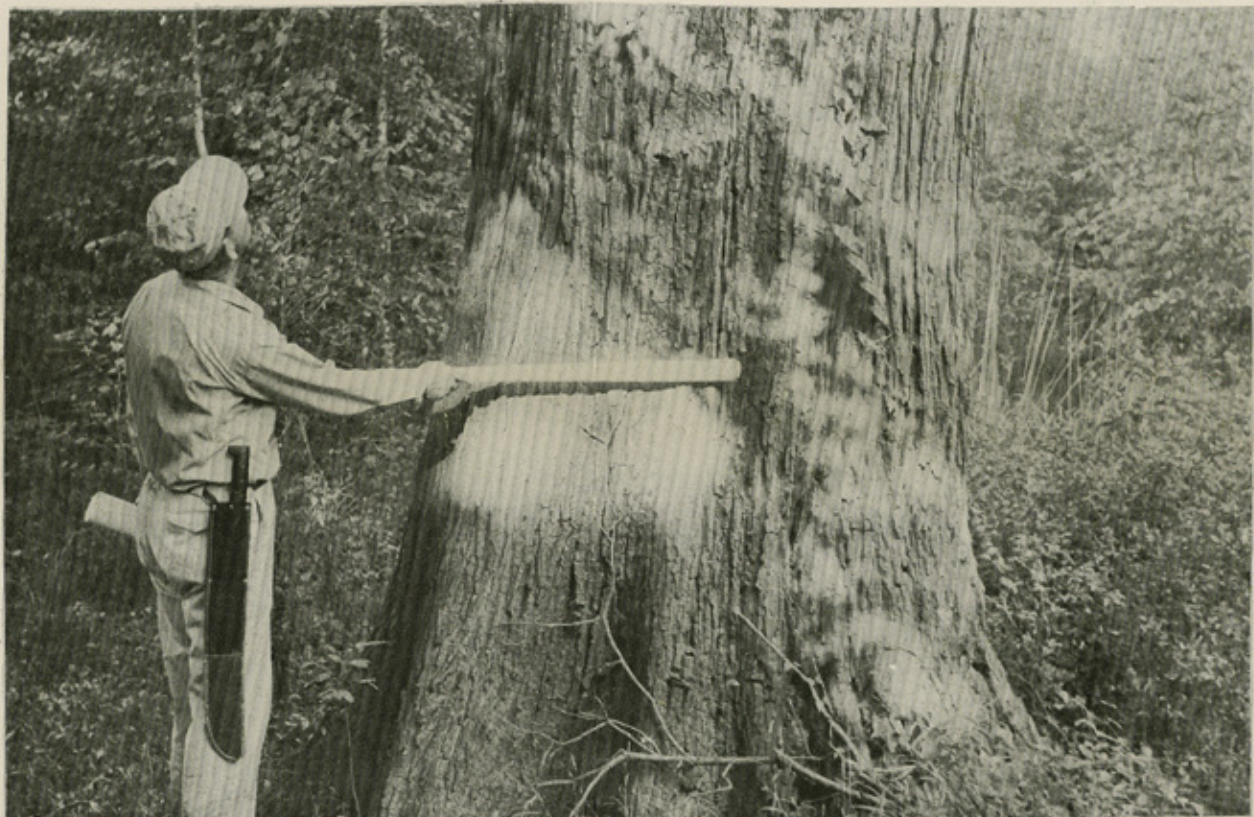
Figure 14. Overcup oak tree 48" in diameter in entrenched valley within 1/4 mile of head of Big Eddy Lake.

The rate at which the delta is building forward into the lake is quite slow. Comparison of airphotos taken over a span of nearly 20 years shows no appreciable difference in the location of the head of the lake. The slow rate of accretion of land to the head of the lake is supported by observation of tree sizes. A large gum tree (figure 13) that must be at least 75 years old is growing at a distance of only about 600 feet from the head of the lake. Larger trees, up to 48 inches in diameter (figure 14), may be found a short distance farther upstream.
