**RECOVERY ACT: RESTORING
 ESTUARINE HABITAT IN WEST
 GALVESTON BAY**

**COASTAL BOUNDARY
 GALVESTON ISLAND STATE PARK
 WEST BAY
 GALVESTON COUNTY, TEXAS**

Project: Recovery Act: Restoring Estuarine Habitat in West Galveston Bay/Galveston Island State Park

Description: Coastal Boundary Survey, dated October 12, 2009, of the Mean High Water line of the northwest boundary of Galveston Island State Park, same being a portion of the southeast boundary of Galveston West Bay, situated on Galveston Island, Galveston County, Texas.

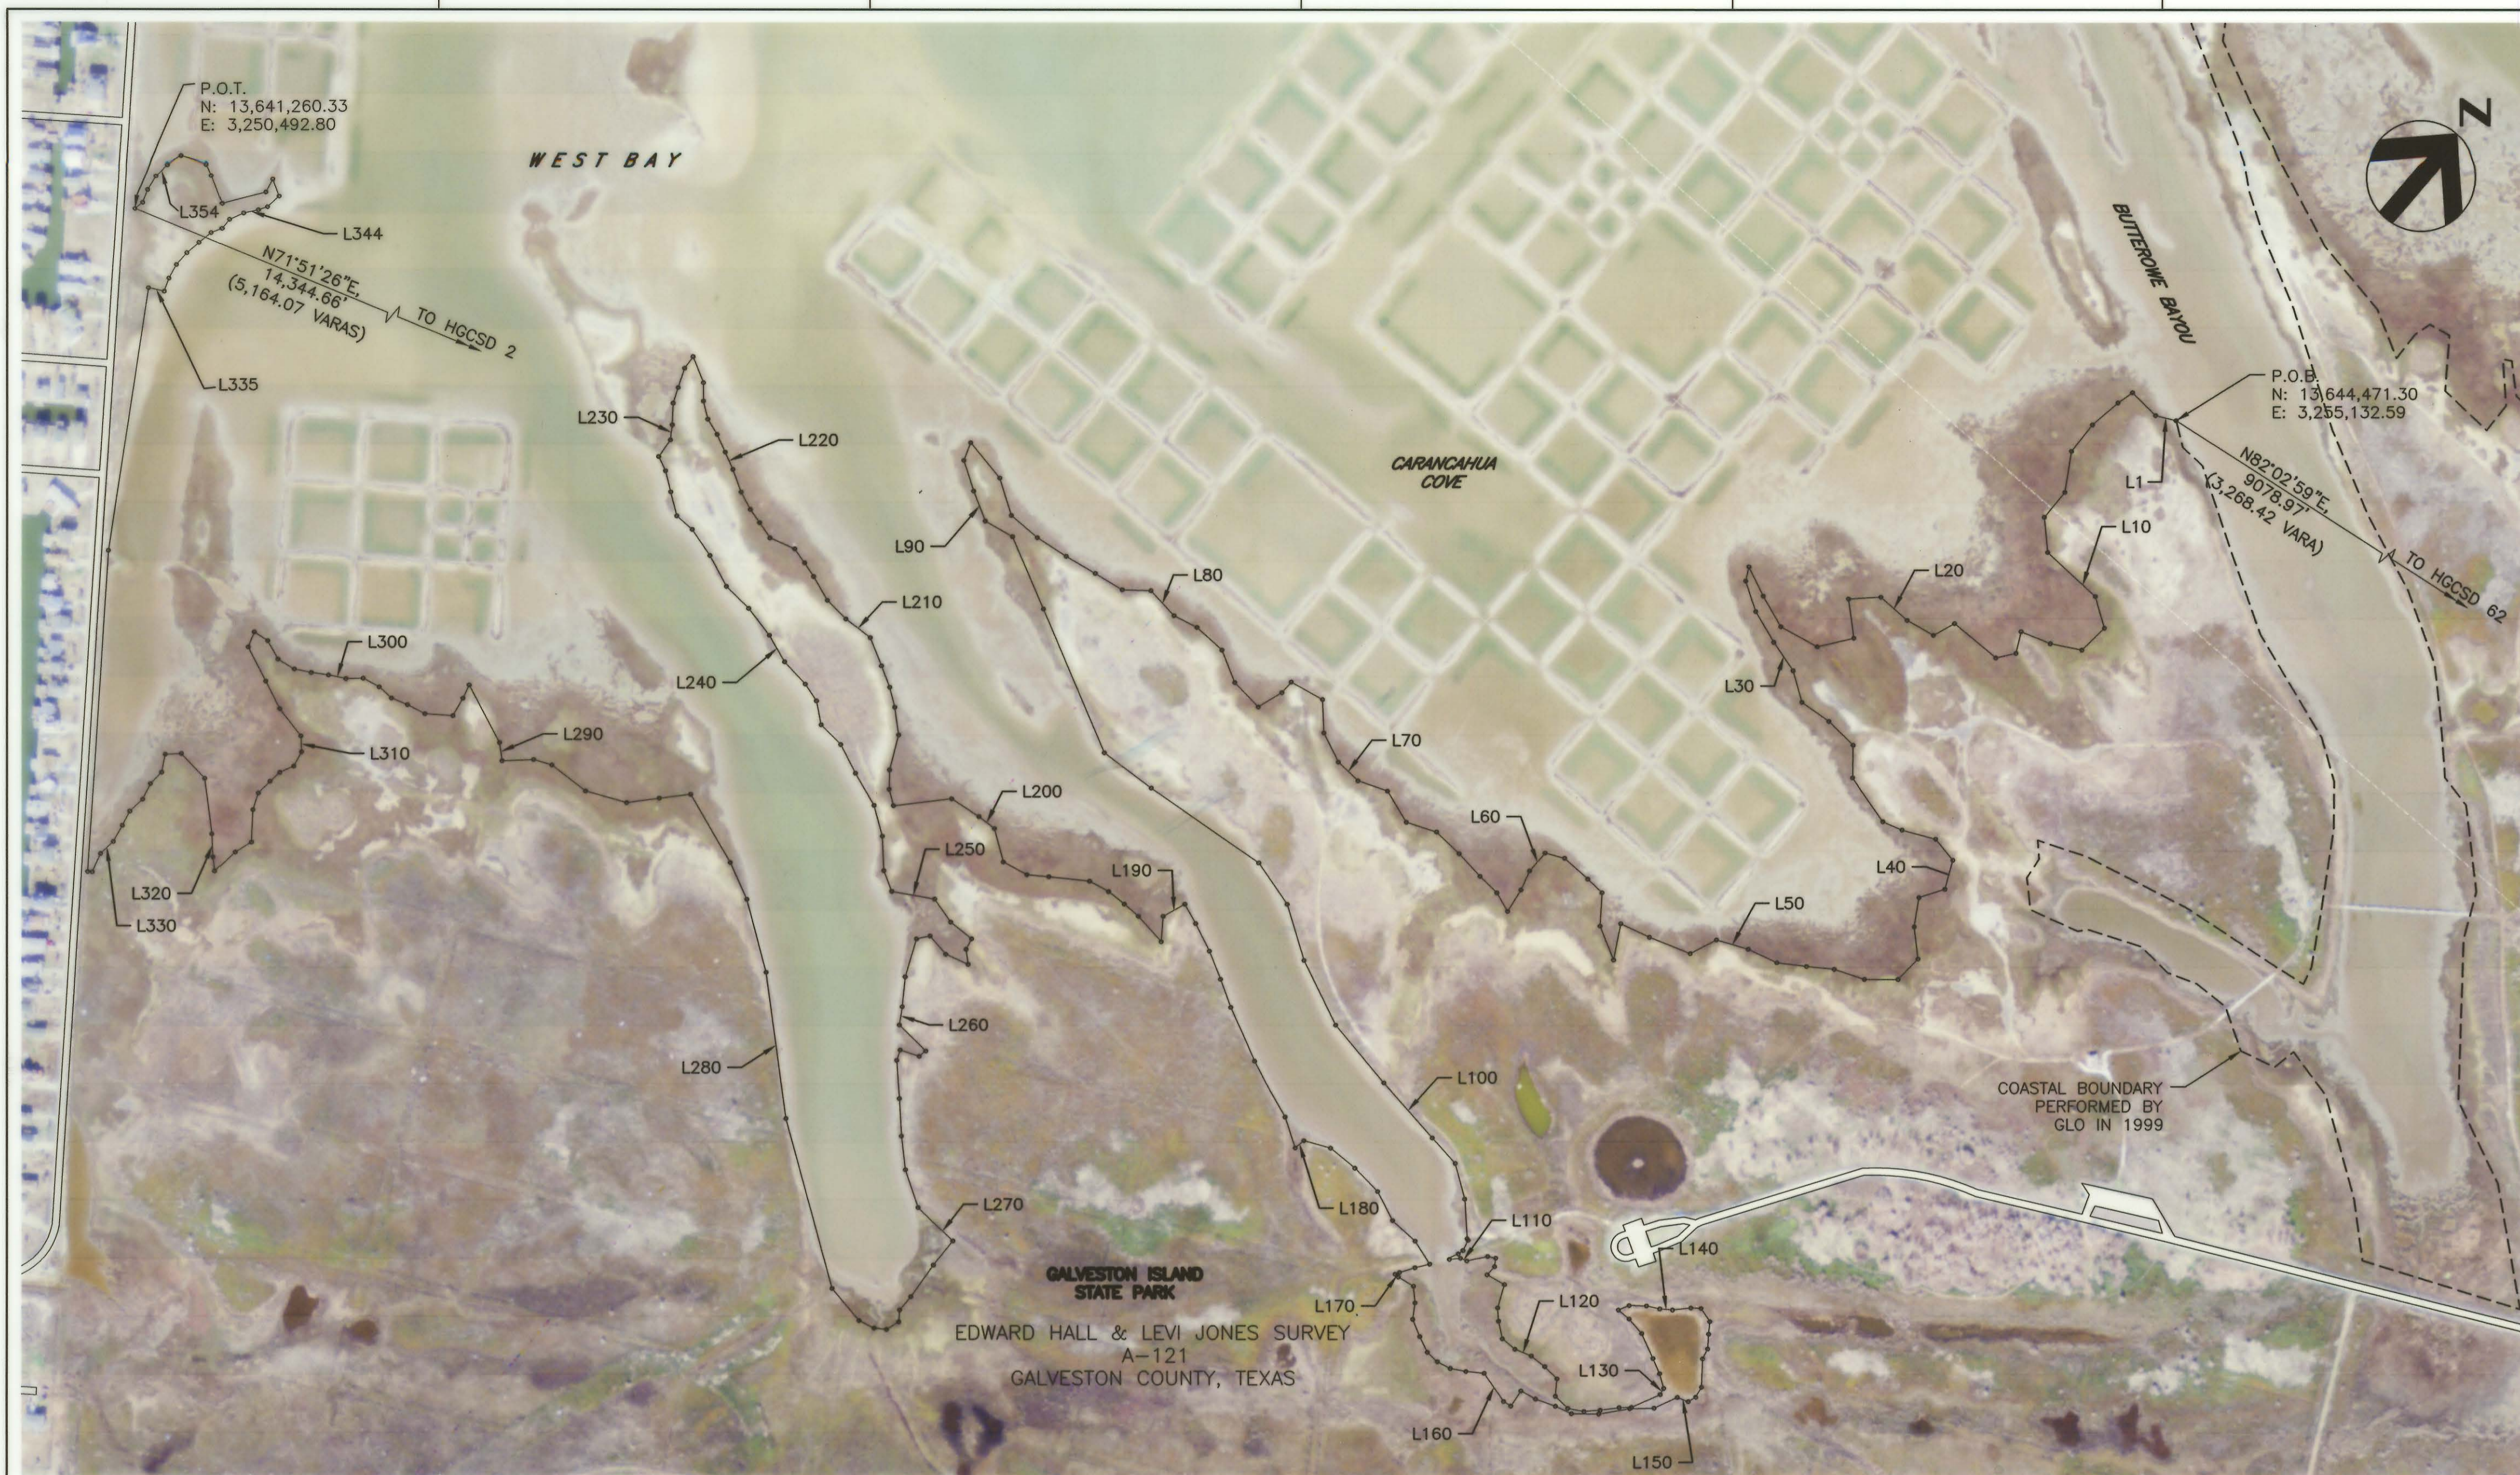
1. ALL SURVEYING WAS PERFORMED BY HDR ENGINEERING, INC. FROM GPS OBSERVATIONS. THIS DRAWING REPRESENTS THE CONDITIONS THAT EXISTED AT THE TIME OF THE SURVEY CONDUCTED AUGUST 18-21, 2009.
2. ALL ELEVATIONS SHOWN ARE IN FEET AND REFERENCED TO NAVD '88.
3. COORDINATES SHOWN ARE GRID IN U.S. FEET AND REFERENCED TO TEXAS COORDINATE SYSTEM, TEXAS SOUTH CENTRAL ZONE, AS DEFINED BY ARTICLE 21.071 OF THE NATURAL RESOURCES CODE OF THE STATE OF TEXAS, 1983 DATUM.
4. MONUMENTS USED FOR HORIZONTAL AND VERTICAL CONTROL WERE:

"HGCS D 62"	N 13,645,727.04 E 3,264,124.31 ELEV. 6.53'
"PARK R.M.2"	N 13,642,375.74 E 3,260,135.69 ELEV. 7.26'
5. MEAN HIGH WATER DETERMINED TO BE 1.15' NAVD '88 BASED ON A THREE DAY STUDY AT THE SITE AND COMPUTATIONS USING THE AMPLITUDE RATIO METHOD AND TCOON GAUGE 022-GALVESTON PIER 21 AS THE CONTROL STATION.

11. UPLAND OWNER: TEXAS PARKS AND WILDLIFE DEPARTMENT
4200 SMITH SCHOOL ROAD
AUSTIN, TX 78744
12. LINES 332, 333 AND 334 CREATED WITH USE OF AERIAL PHOTOGRAPHY. LINE 333 GENERALLY FOLLOWS THE COURSE OF CONCRETE RUBBLE RIP RAP.

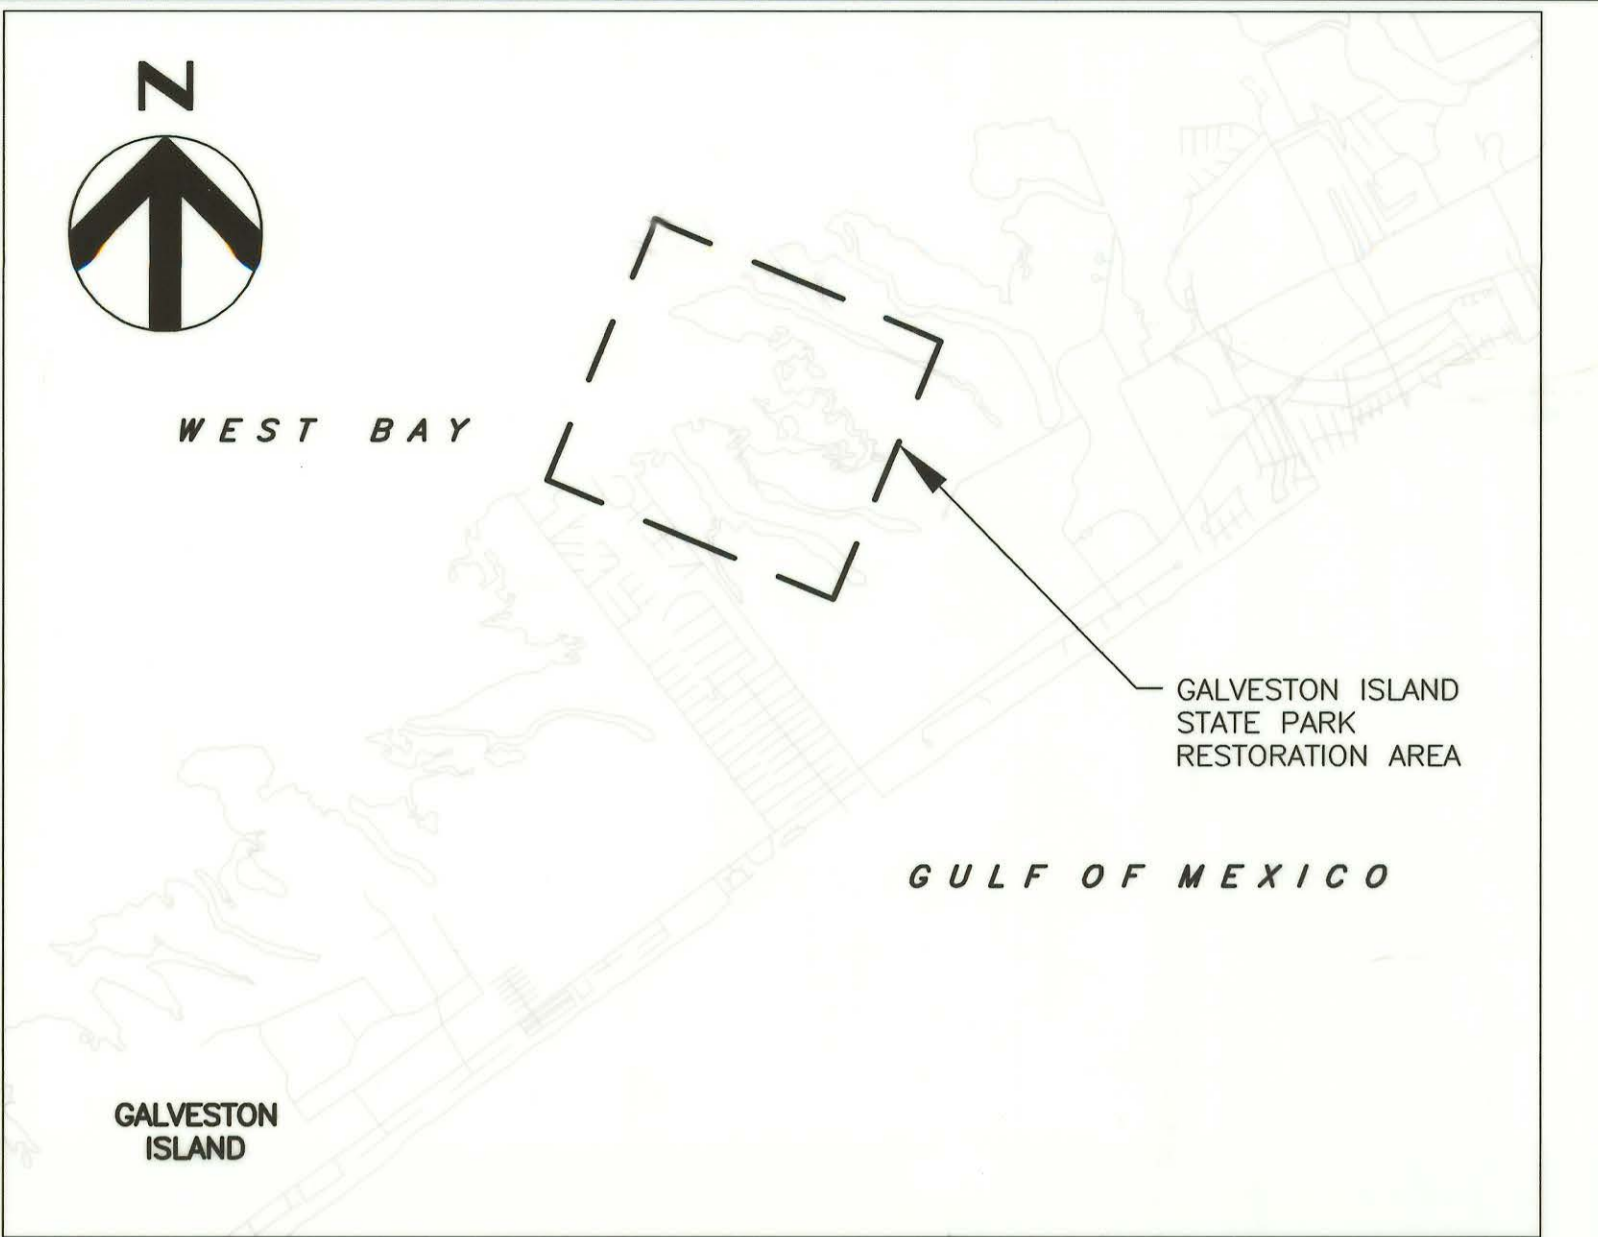
6. BASIS OF BEARINGS IS "TEXAS COORDINATE SYSTEM" PER SECTION 21.071 OF THE NATURAL RESOURCES CODE.
7. DISTANCES AND BEARINGS ARE GRID. SCALE FACTOR FOR "HGCS D 62" IS 0.99986954, CONVERGENCE IS +1"-59"-24.8.

9. NO RETAINING WALLS OR OTHER STRUCTURAL MODIFICATIONS HAVE BEEN PLACED ON OR ALONG THE LITTORAL BOUNDARY
10. AERIAL PHOTOGRAPH WAS OBTAINED FROM THE TEXAS GENERAL LAND OFFICE AND WAS FLOWN IN JANUARY 2009.

I, GEORGE RUBALCABA, LICENSED STATE LAND SURVEYOR, HEREBY STATE THAT THIS DRAWING REPRESENTS THE CONDITIONS THAT EXISTED AT THE TIME OF THE MEAN HIGH WATER (MHW) LINE SURVEY CONDUCTED AUGUST 18-21, 2009. TO THE BEST OF MY KNOWLEDGE, THERE IS NO ARTIFICIAL FILL OR ACCRETION LOCATED WITHIN THE SURVEYED AREA.
