Re: Blanco Creek in Uvalde County.

Navigability determination of Blanco Creek

Re: Blanco Creek, Uvalde County, Texas

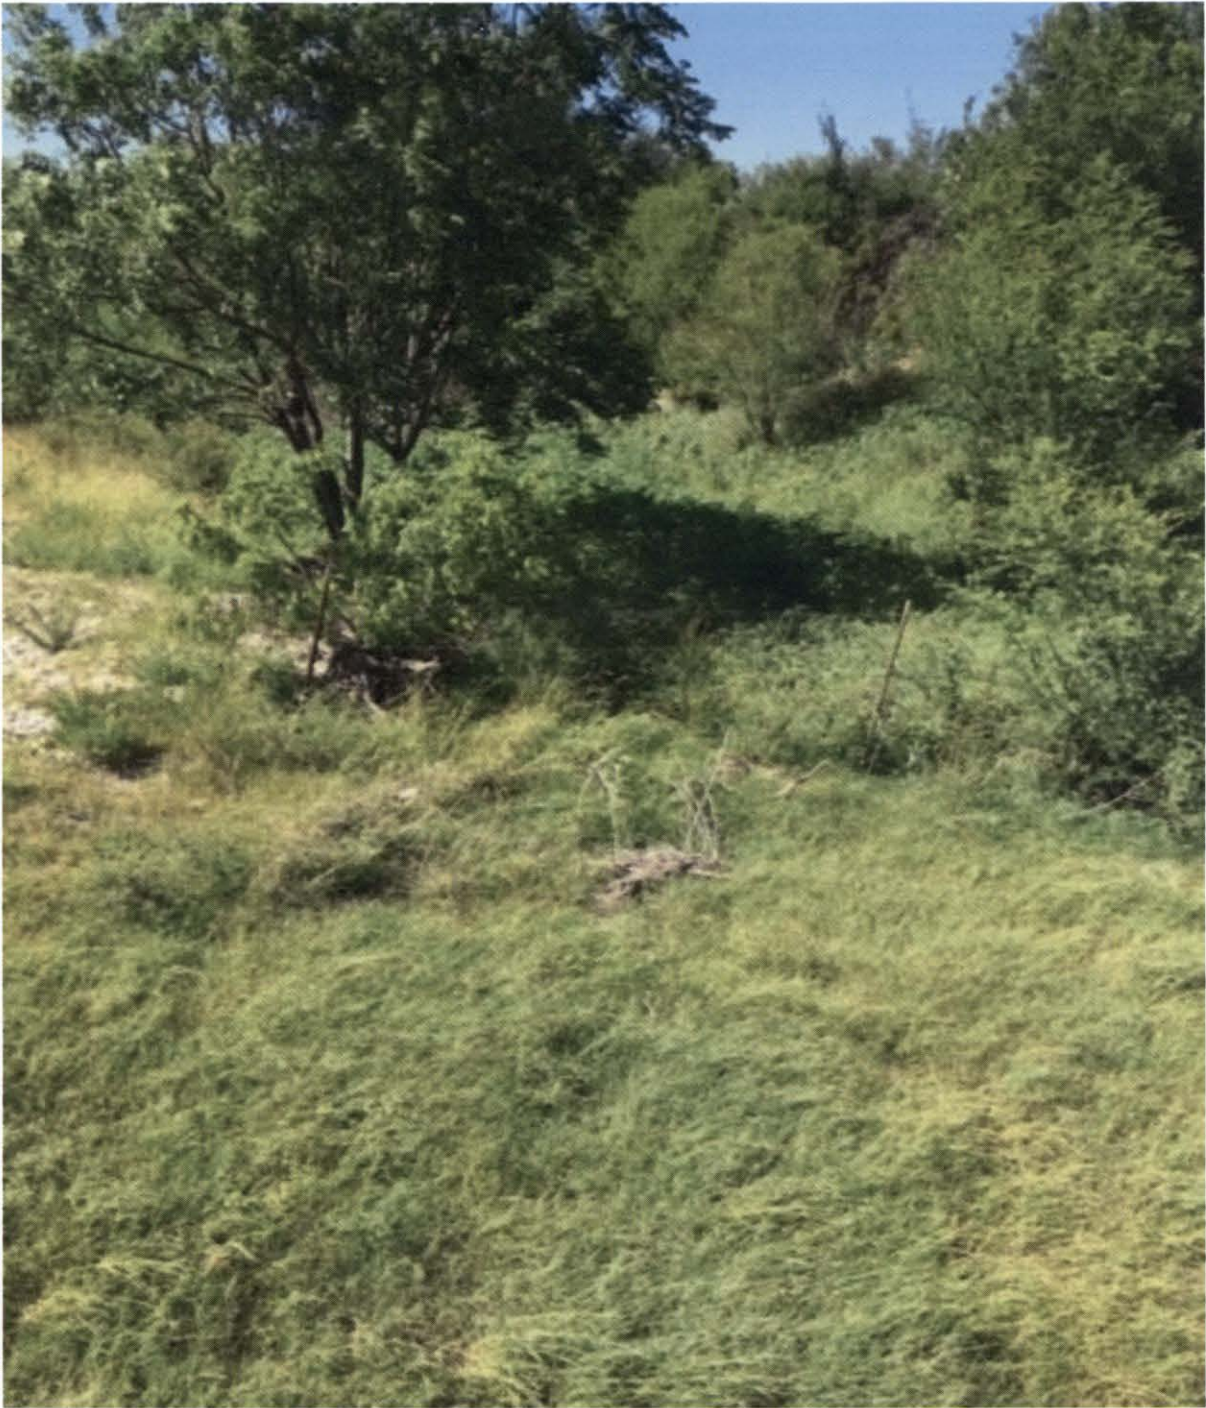
Our first stop was at the Highway 127 crossing over Blanco creek. At this location the stream bed is narrow, less than 30-ft in width. It was over grown with upland grasses, there are no visible rocks and gravel, and no water was visible. Below is an image of a Google Earth .kmz file at this location and a photograph taken at the location.

Caption: view upstream from Hwy 127 bridge crossing Blanco Creek.

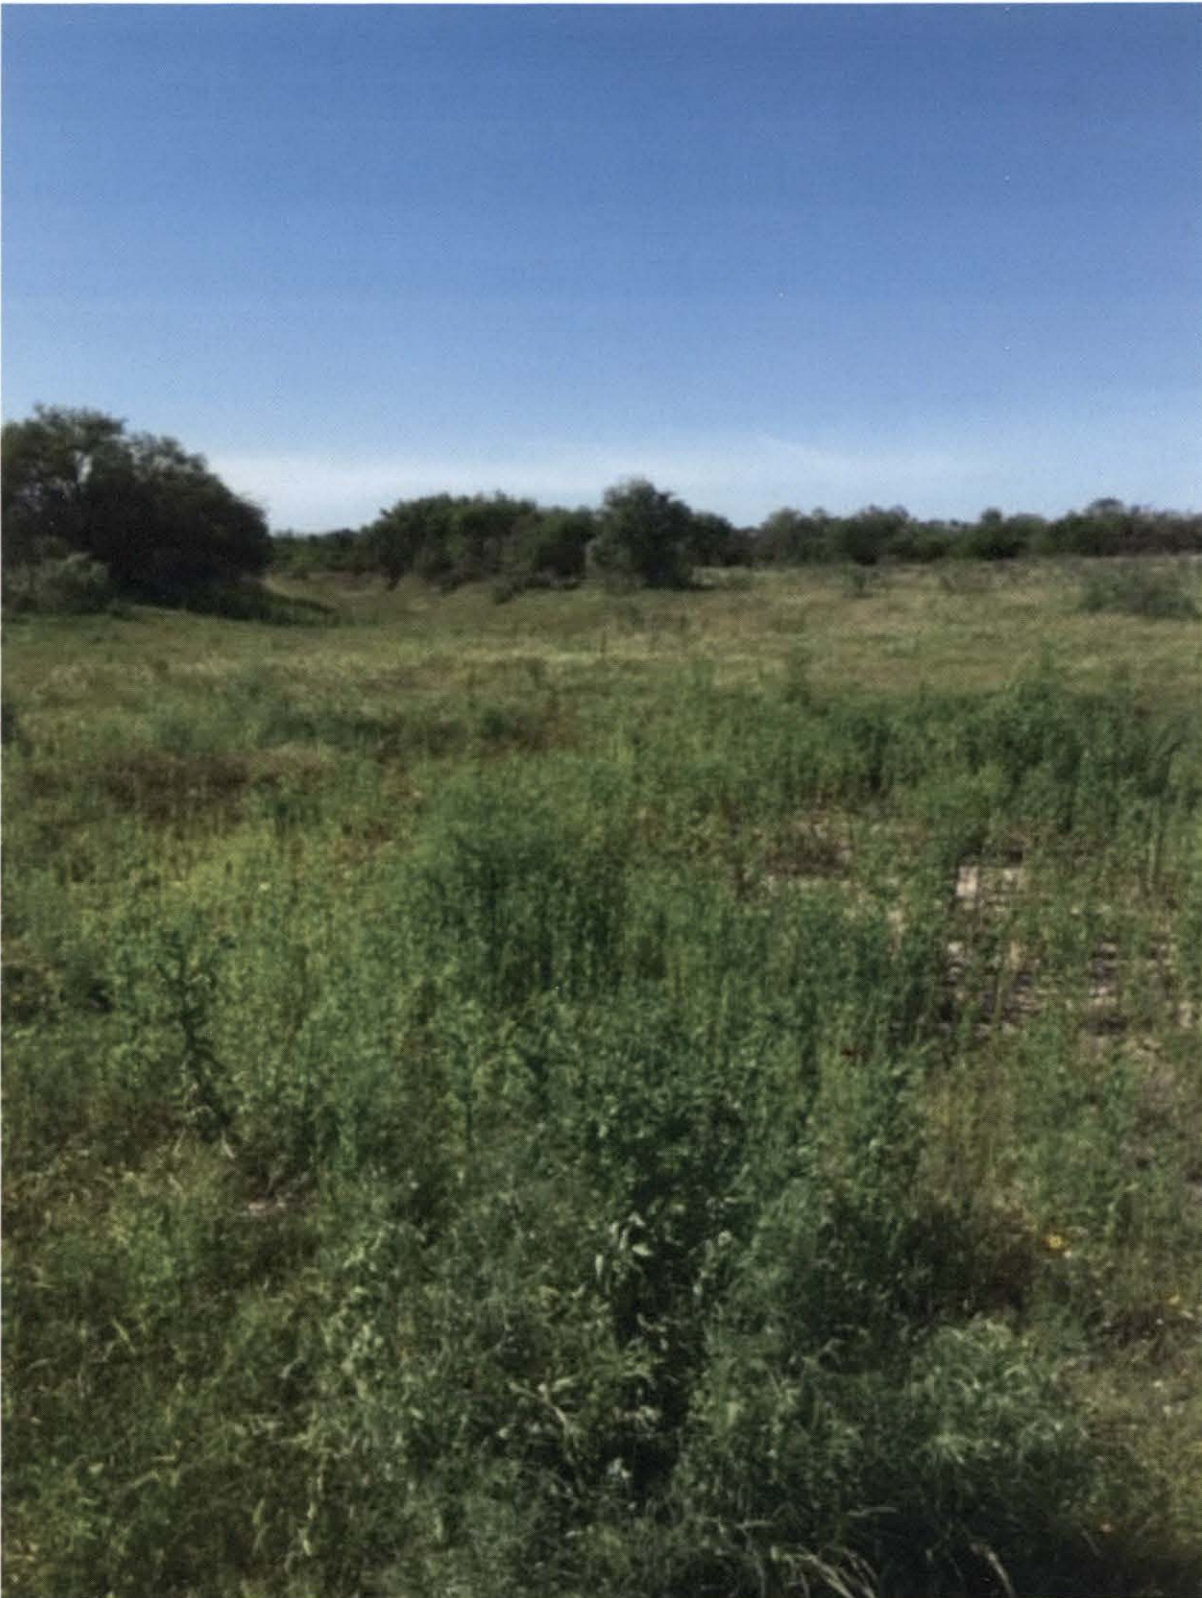
Streambed is narrow, less than 30-feet wide, not well defined and covered in upland grasses. No water in stream. Below is an image of a Google Earth .kmz file at this location and a photograph taken at the location.

Caption: view north from observation point on Blanco Creek.

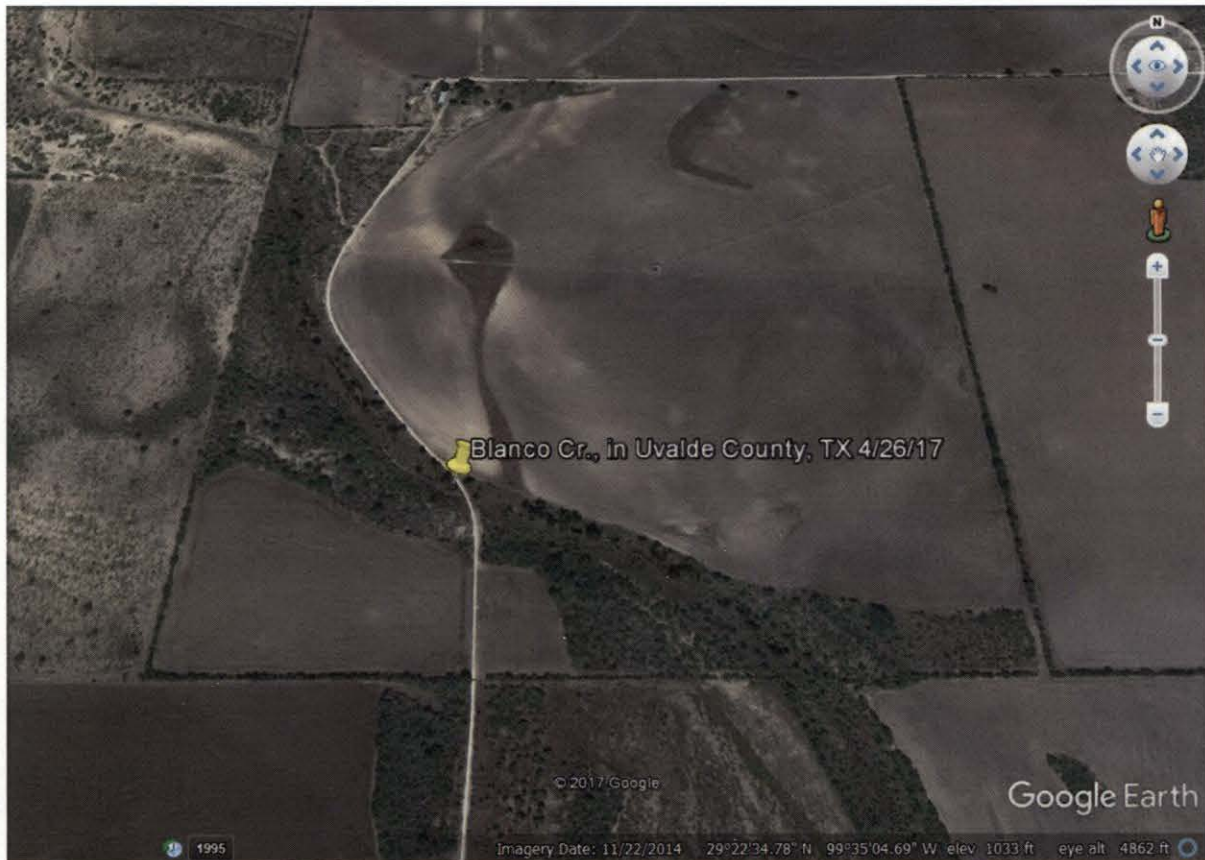
4. Lat. 29° 22' 32.14" N, Lon. 99° 35' 12.31" W.
Streambed is narrow with better definition than previous observation points; less than 30-feet wide; covered in upland grasses. No water was visible in the stream. Below is an image of a Google Earth .kmz file at this location and a photograph taken at the location.

Caption: Image of Google Earth .kmz file for location of observations on Blanco Creek.

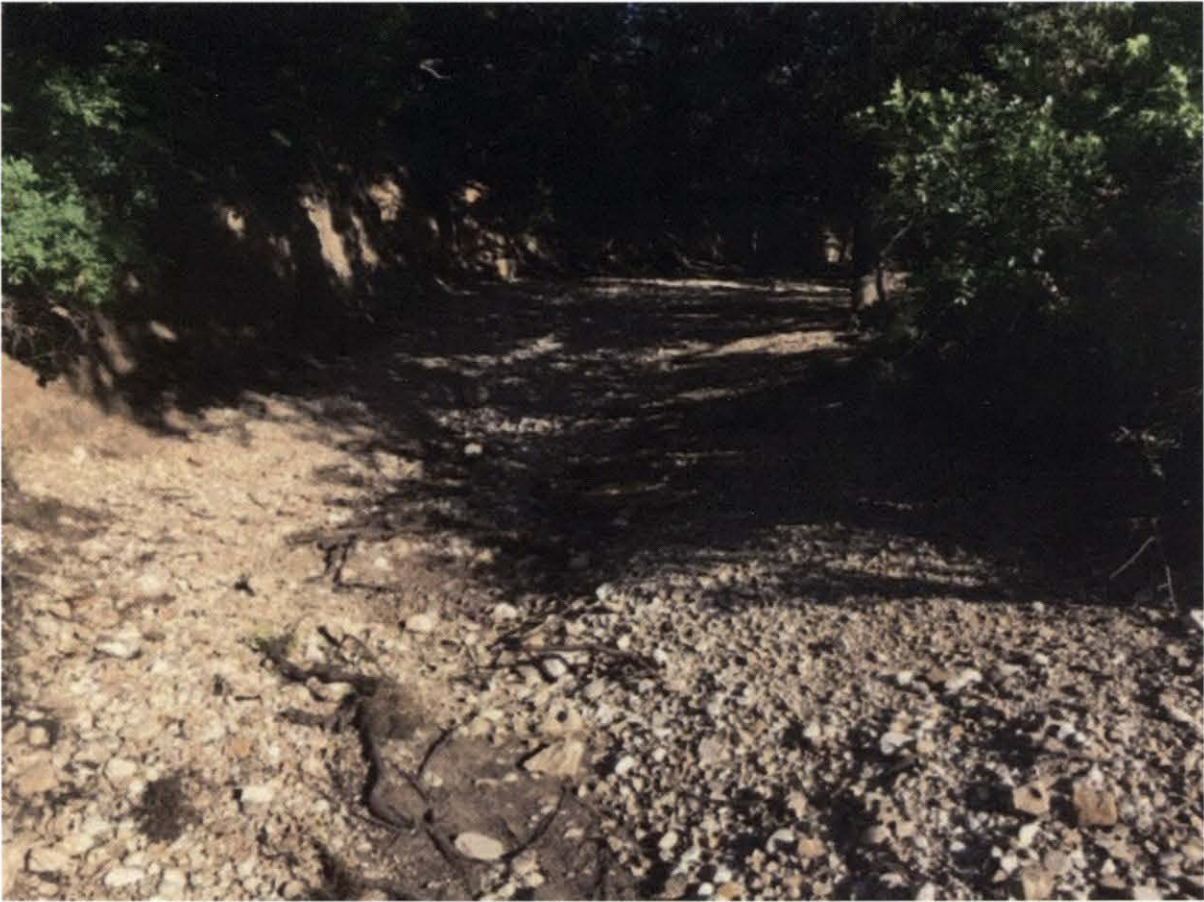
This location is at a county road crossing with Blanco Creek. Streambed here is narrow but with better definition looking upstream; downstream the creek flattens out with less definition. Less than 30-ft wide. Below is an image of a Google Earth kmz file at this location and a photograph taken at the location.

Caption: view looking upstream of Blanco Creek from County Road.

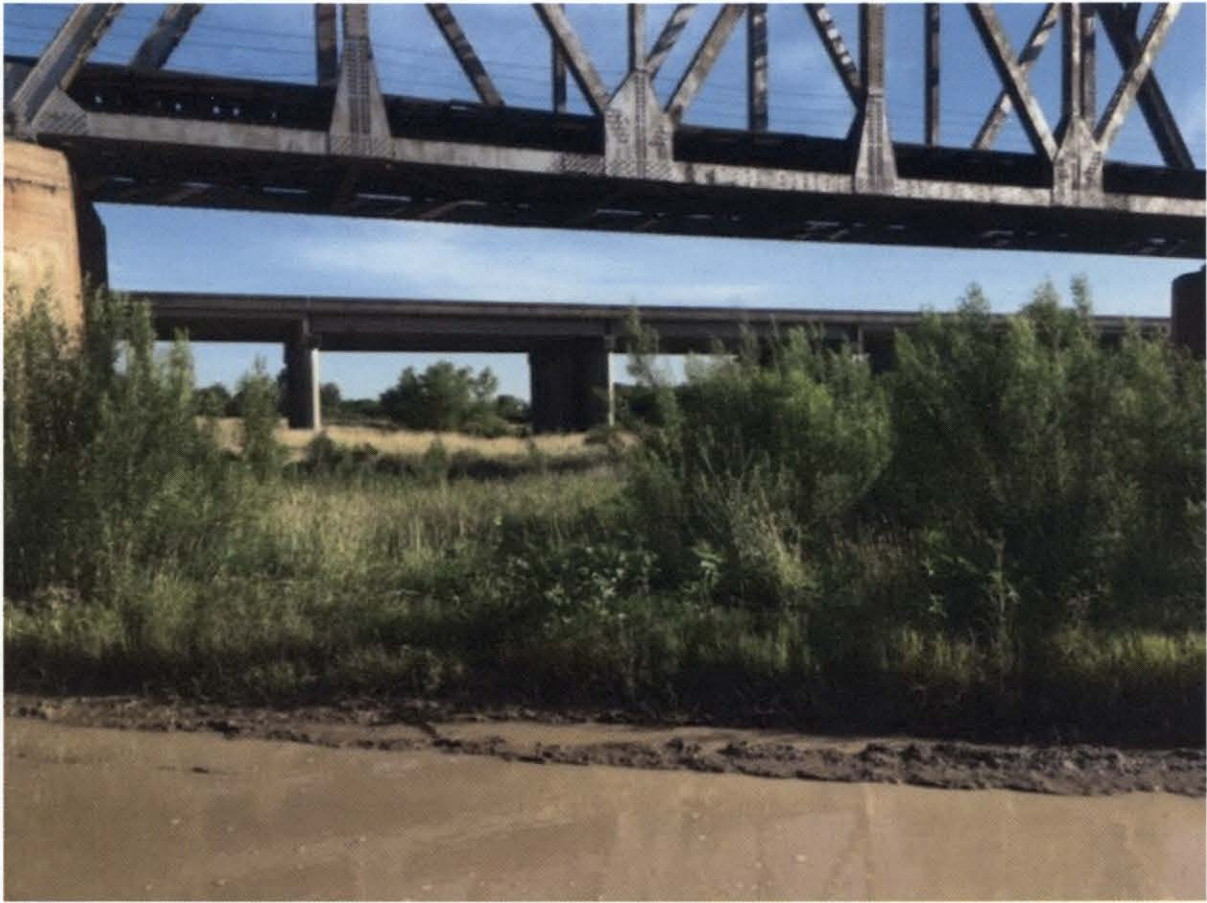
This location is at the creek crossings of the railroad tracks and Highway 90. There is a puddle of water in the road, perhaps from a recent rain, but no other water. Streambed is not well defined and vegetated with upland grasses; less than 30-feet wide. Final observation point for the day. Below is an image of a Google Earth .kmz file at this location and a photograph taken at the location.

Caption: view looking downstream from railroad crossing toward Hwy 90.

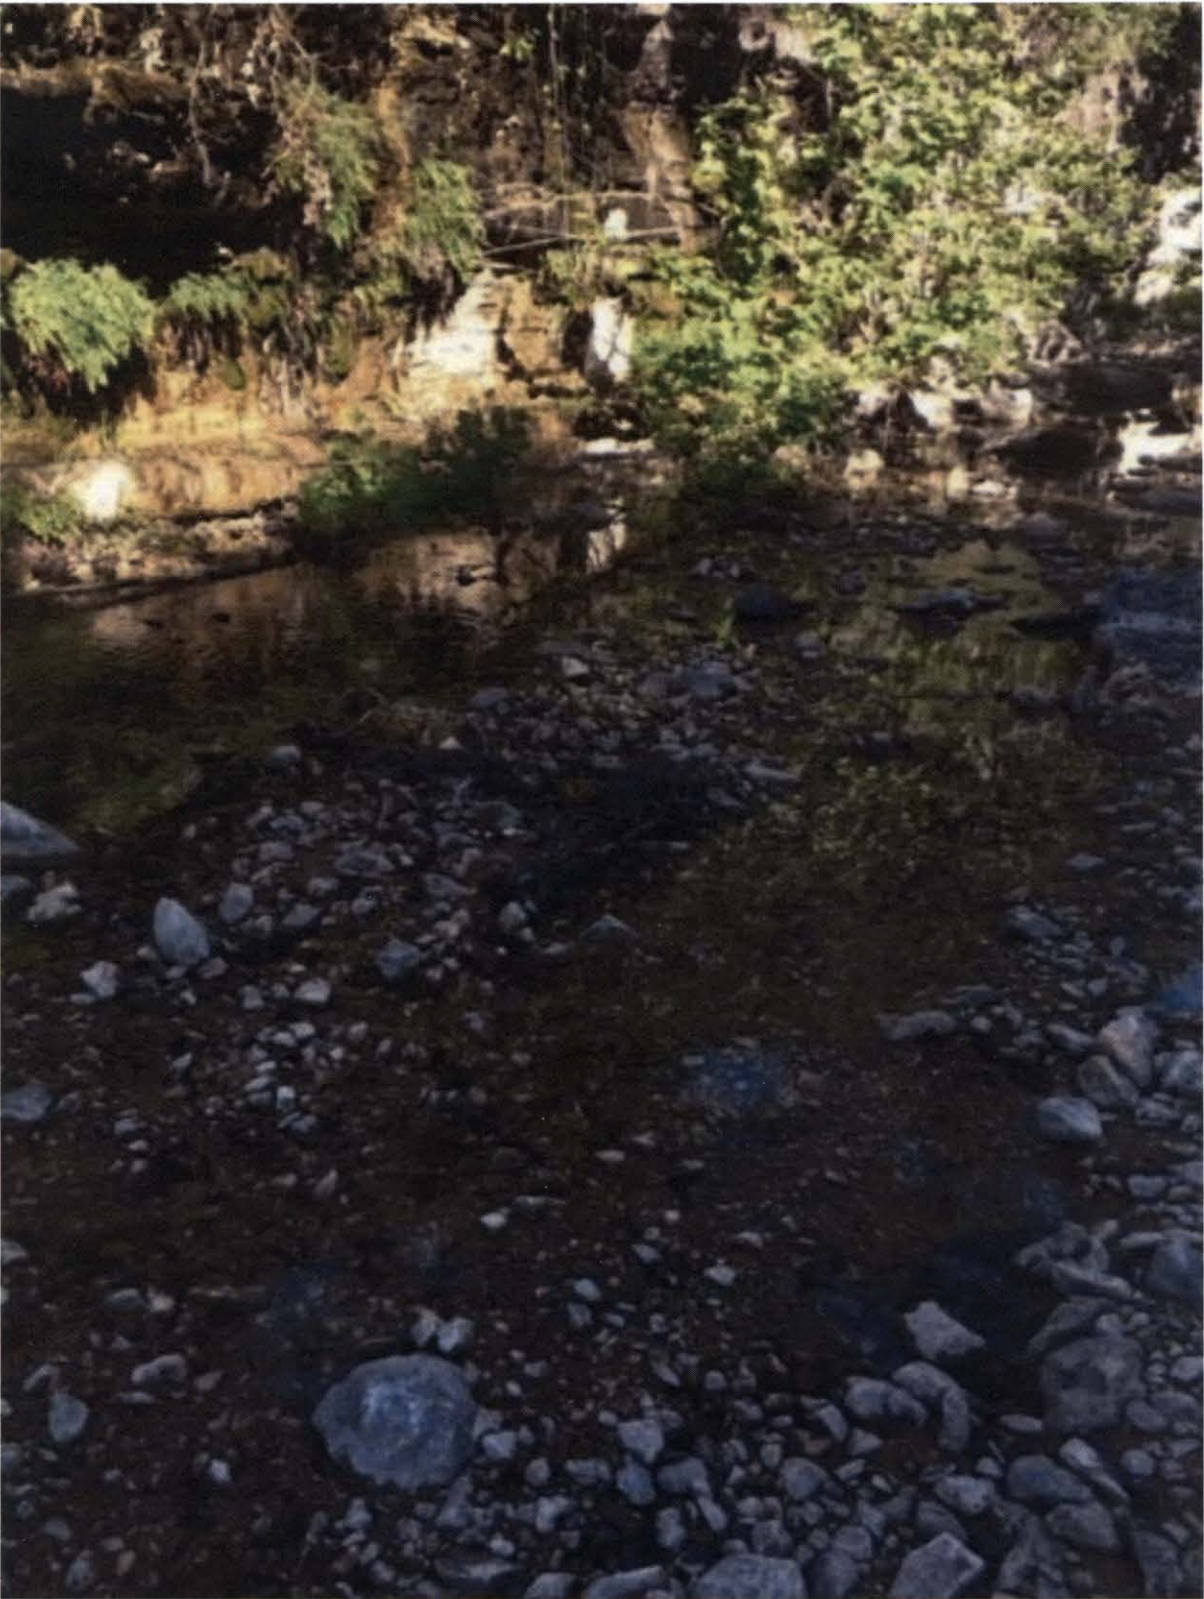
This is the furthest upstream location we visited on the creek; it is at the confluence of two tributaries near the headwaters of Blanco Creek. The banks and bed of the stream are well defined. The bottom is solid rock and water was running in the stream. I measured a distance of 16 feet across, bank to bank. Below is an image of a Google Earth .kmz file at this location and a photograph taken at the location.

Caption: Blanco Creek at observation location.

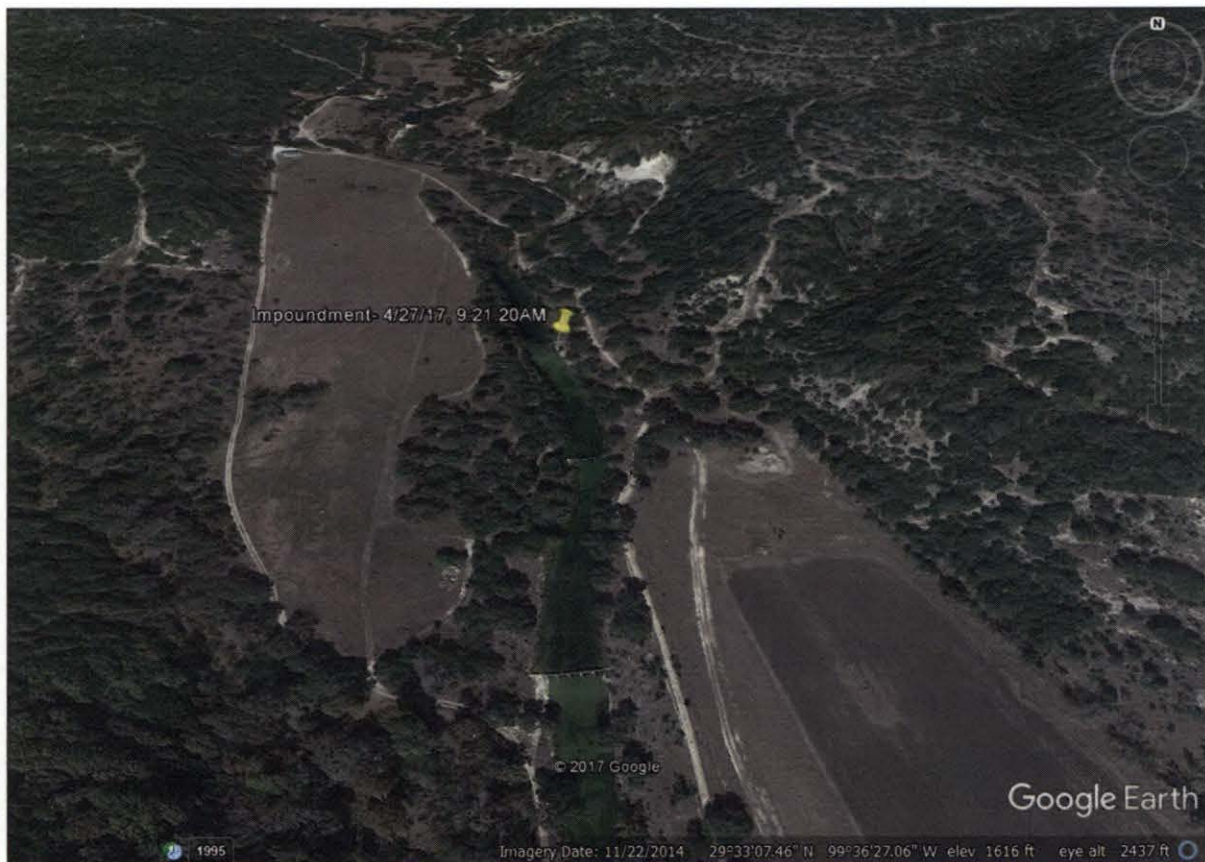
9. Lat. 29° 33' 10.97" N, Lon. 99° 36' 28.12" W.

This location is at an impoundment structure on Blanco Creek. Below is an image of a Google Earth .kmz file for this location and a photograph of the impounded water. The stream bed and banks at this location are not natural; a measurement across the formed body of water was not useful.

Caption: Image of Google Earth .kmz file for location of observations on Blanco Creek.

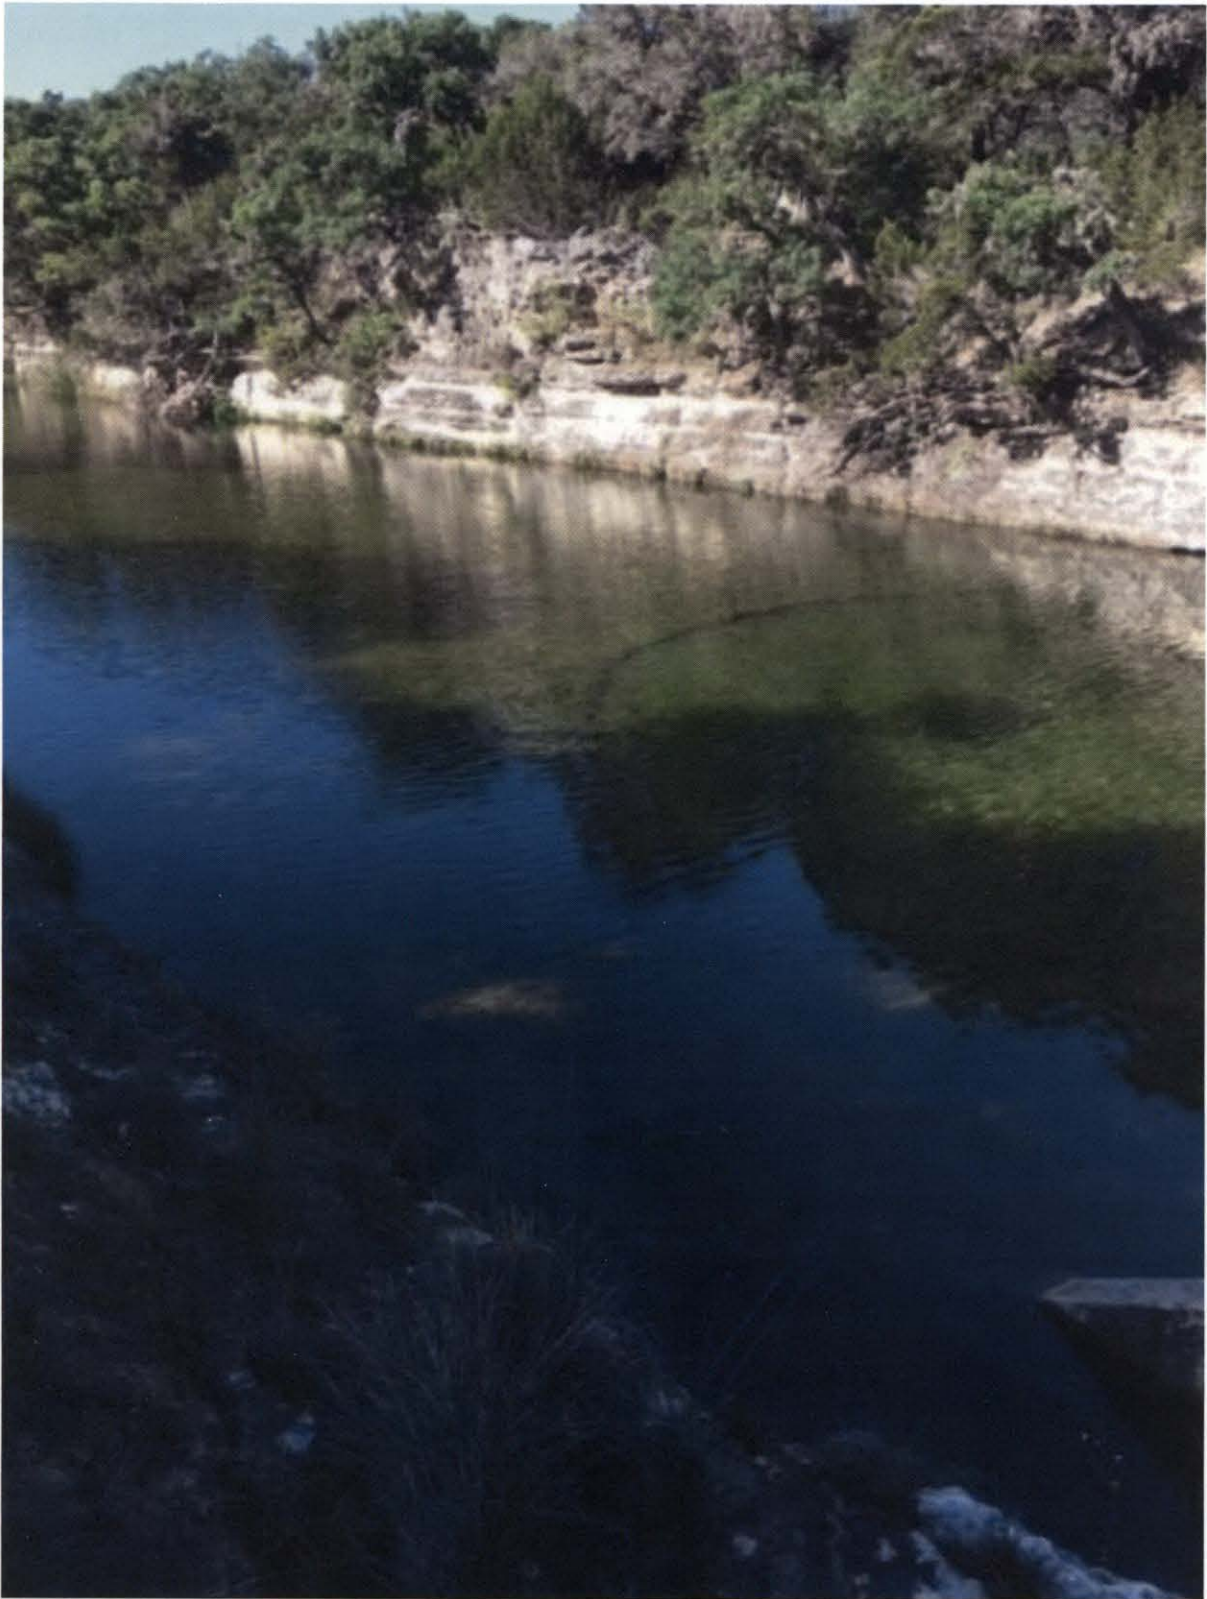
Caption: image of Blanco Creek at observation location.

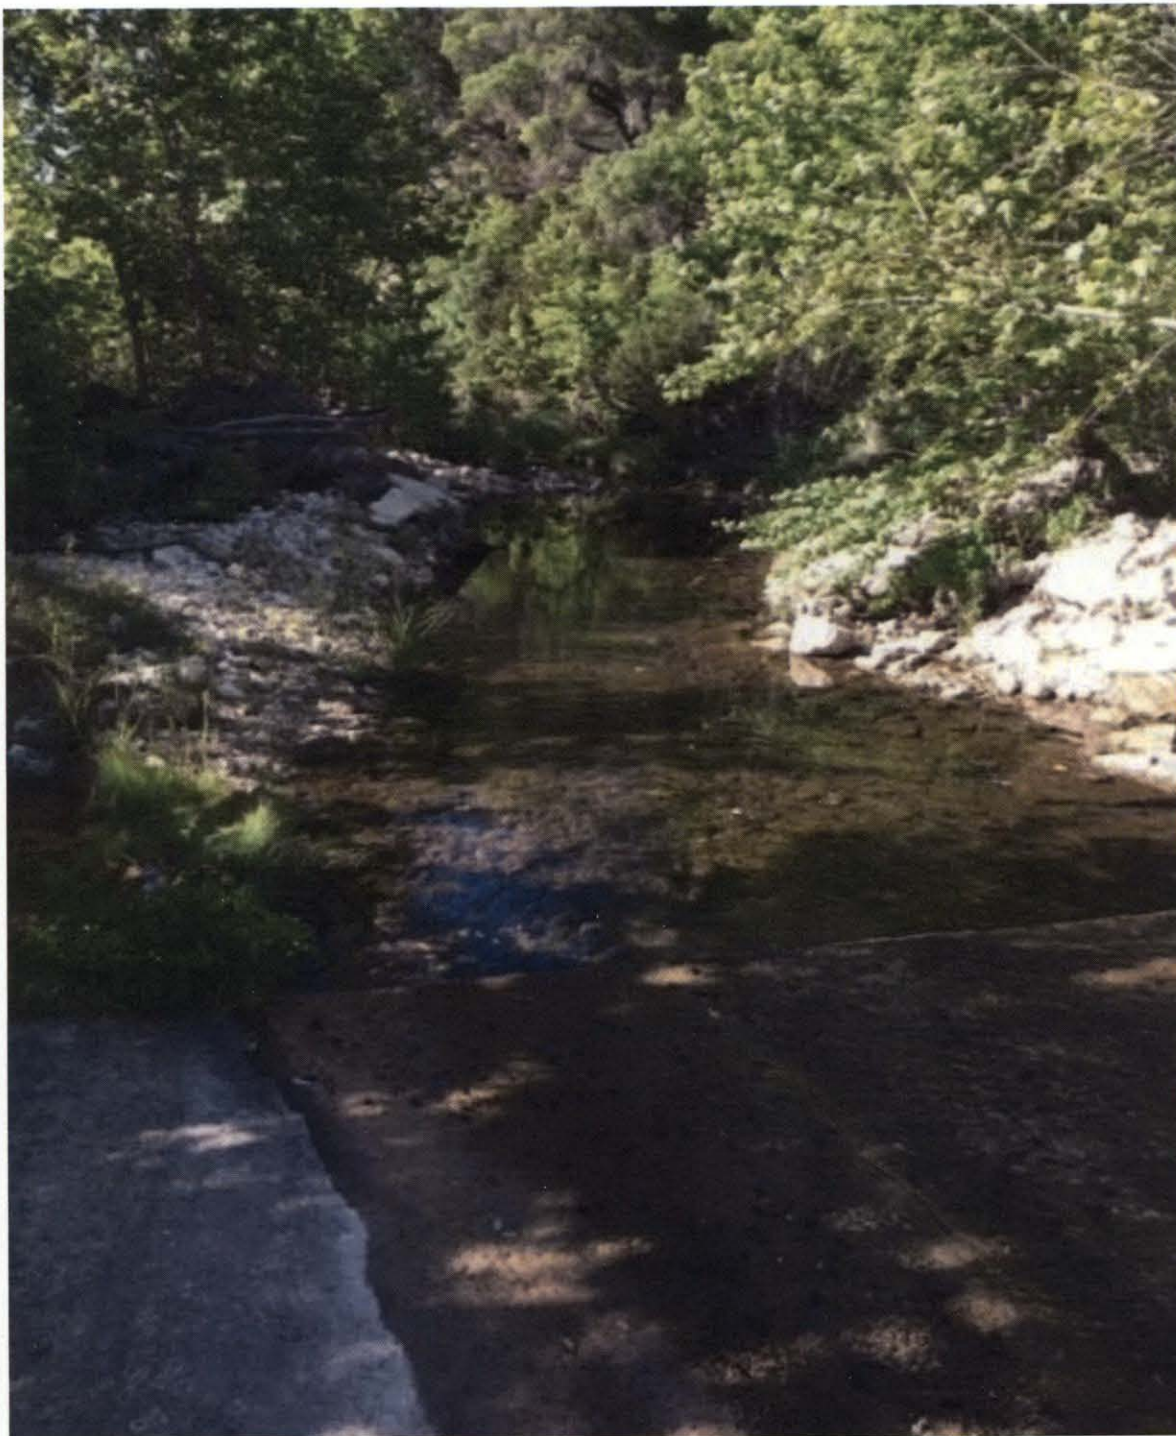
This observation was made on a concrete dam, approximately 70 feet long, and the furthest downstream impoundment structure on Dr. Dehnisch's property. Creek appears to be in a natural state flowing below the dam; bed is narrow and far less than 30 feet in width. Below is an image of a Google Earth .kmz file at this location and two photographs taken at the location.

Caption: image of Blanco Creek looking downstream of concrete dam.

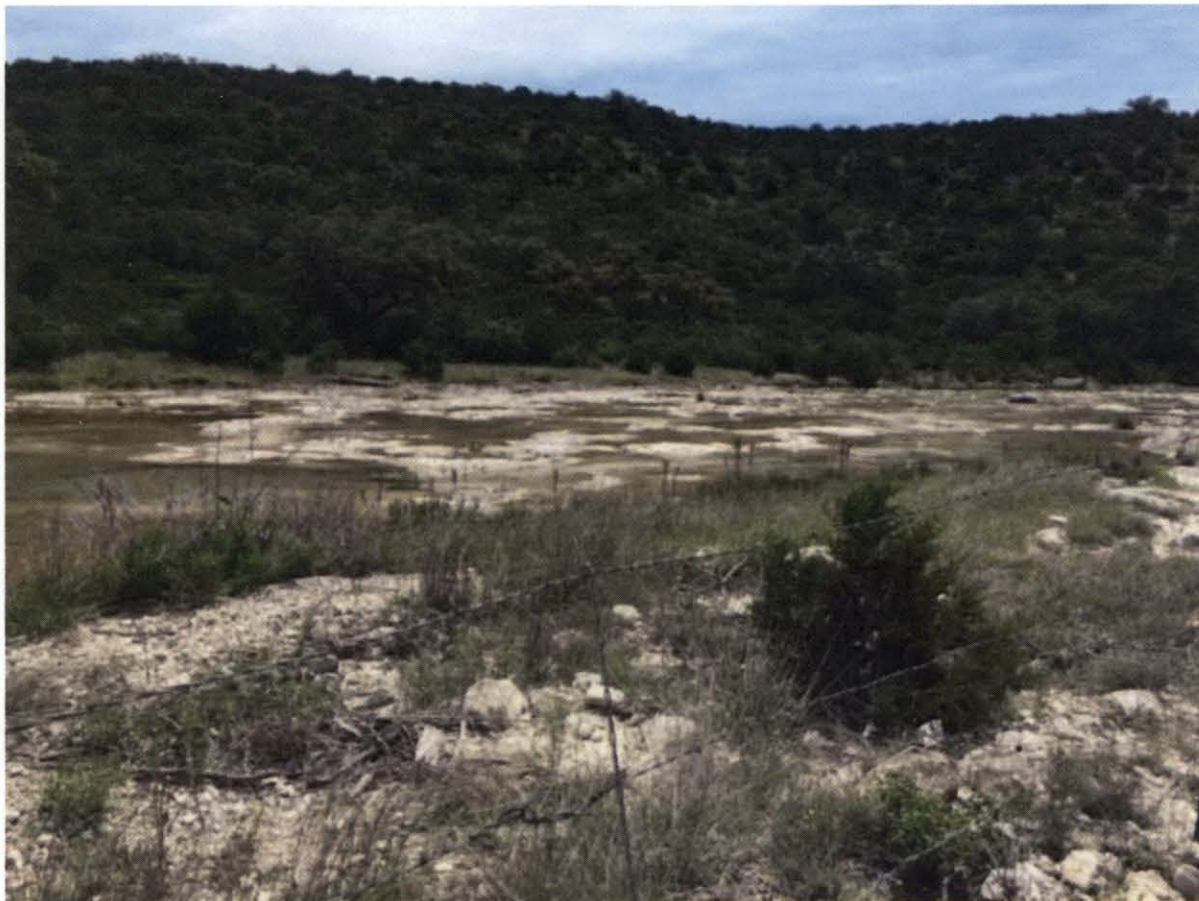
Blanco Creek is shallow and wide at this location; measured 81 feet wide. Below is an image of a Google Earth .kmz file at this location and a photograph taken at the location.

Caption: image of Blanco Creek at observation location.

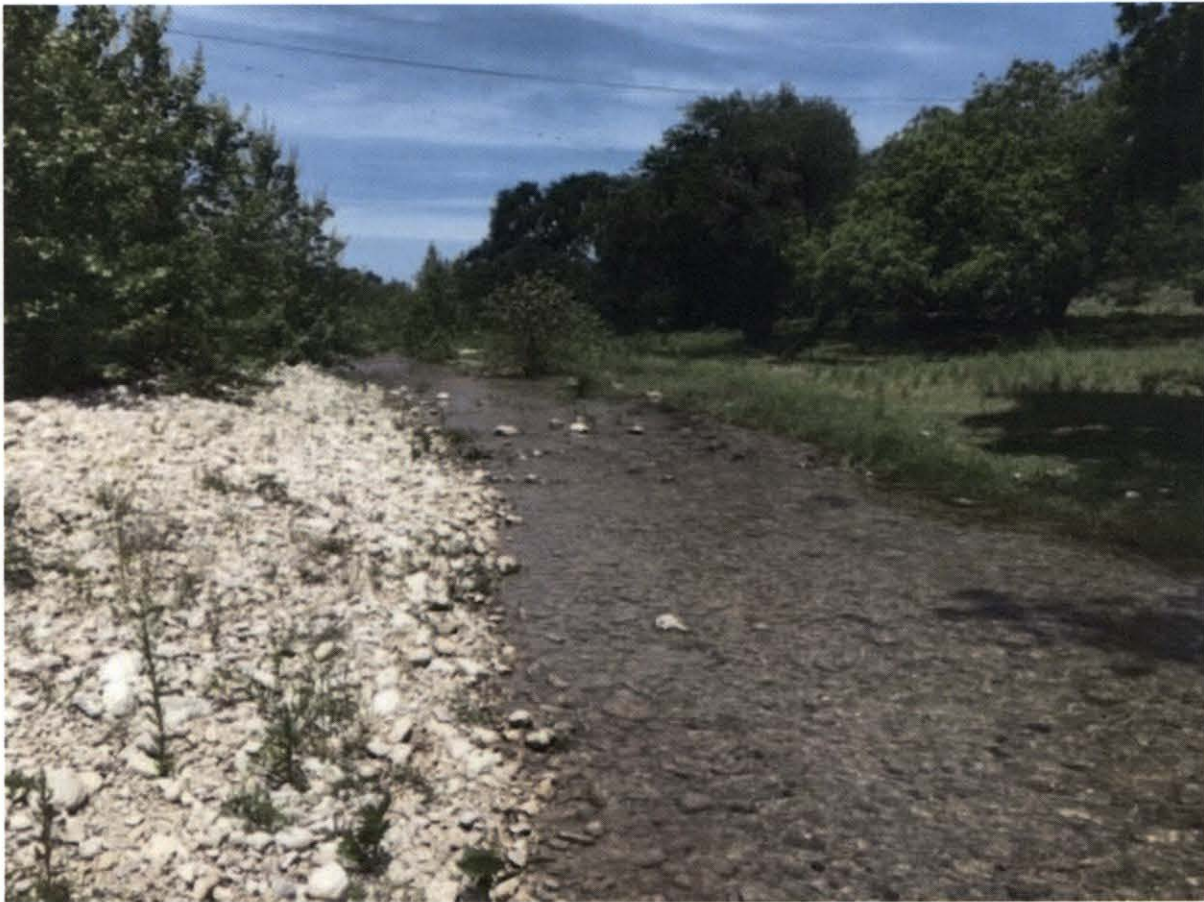
The creek is shallow in this location with rocky bottom and low banks. Upland vegetation grows along the banks. Measured 16 feet across the stream. Below is an image of a Google Earth .kmz file at this location and a photograph taken at the location.

Caption: image of Blanco Creek looking upstream at observation location.

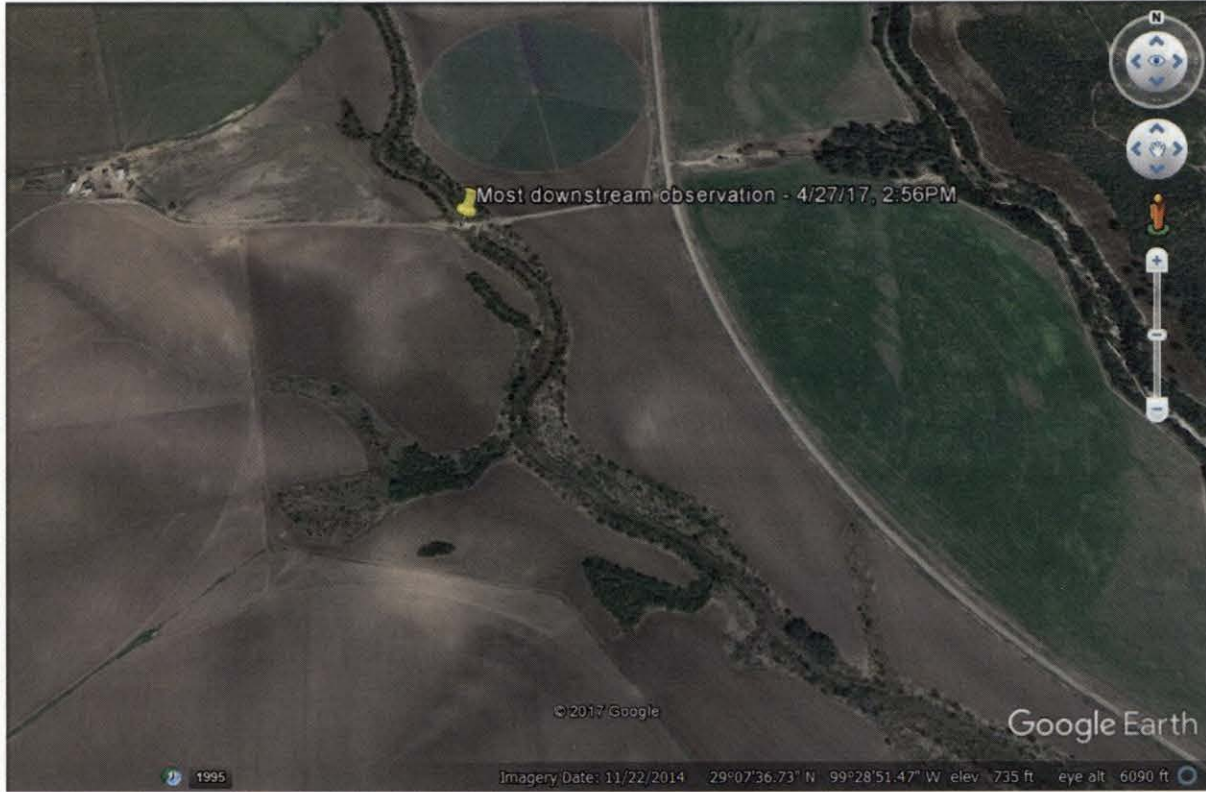
18. Lat. 29° 07' 50.81" N, Lon. 99° 29' 02.87" W.

This location is at a private road crossing of the creek and is the most southern, downstream location observed being approximately 2.5 miles upstream from the Blanco Creek confluence with the Frio River. There was no water running over or under the crossing. Streambed is not well defined in this area and I was not able to make a measurement of the creek width. Below is an image of a Google Earth .kmz file at this location and a photograph taken at the location.

Caption: Image of Google Earth .kmz file for location of observations on Blanco Creek.

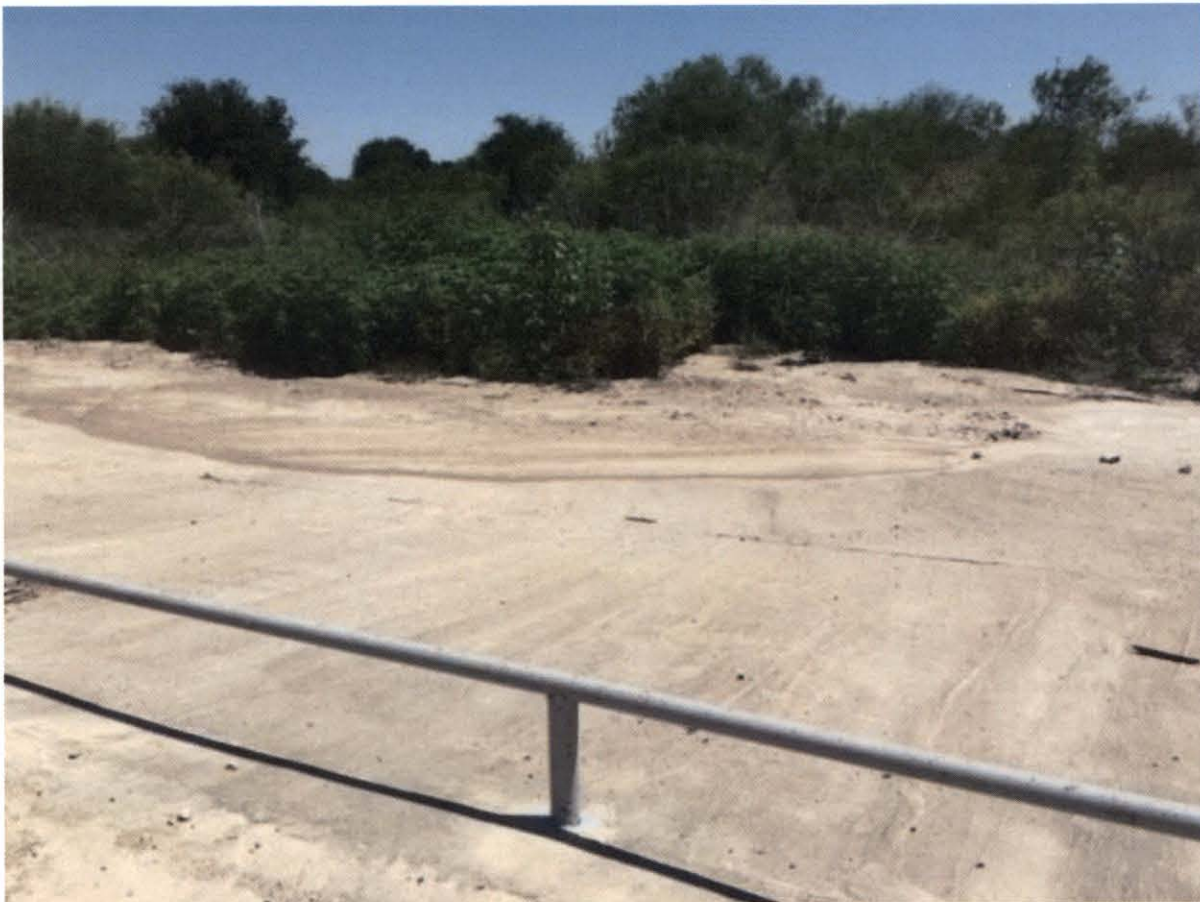
Caption: image of Blanco Creek looking upstream from concrete road structure spanning creek.
