EXHIBIT OF MEAN HIGHER HIGH WATER  
ALONG CLEAR LAKE, SITUATED ALONG THE  
M. MULDOON TWO LEAGUE GRANT,  
ABSTRACT NO. 18,  
CITY OF LEAGUE CITY,  
GALVESTON COUNTY, TEXAS

TEXAS GENERAL LAND OFFICE  
Art. 33.136, Natural Resources Code  
Co. Galveston, sketch No. 40, sheet 1  
File Date 2/6/2006 by P.J.H.  
See Report - Sheet 2, counter 8302

Re: Clear Lake adjacent to M. Muldoon Two League Grant, South Shore Harbor, League City,  
Galveston County, Texas.

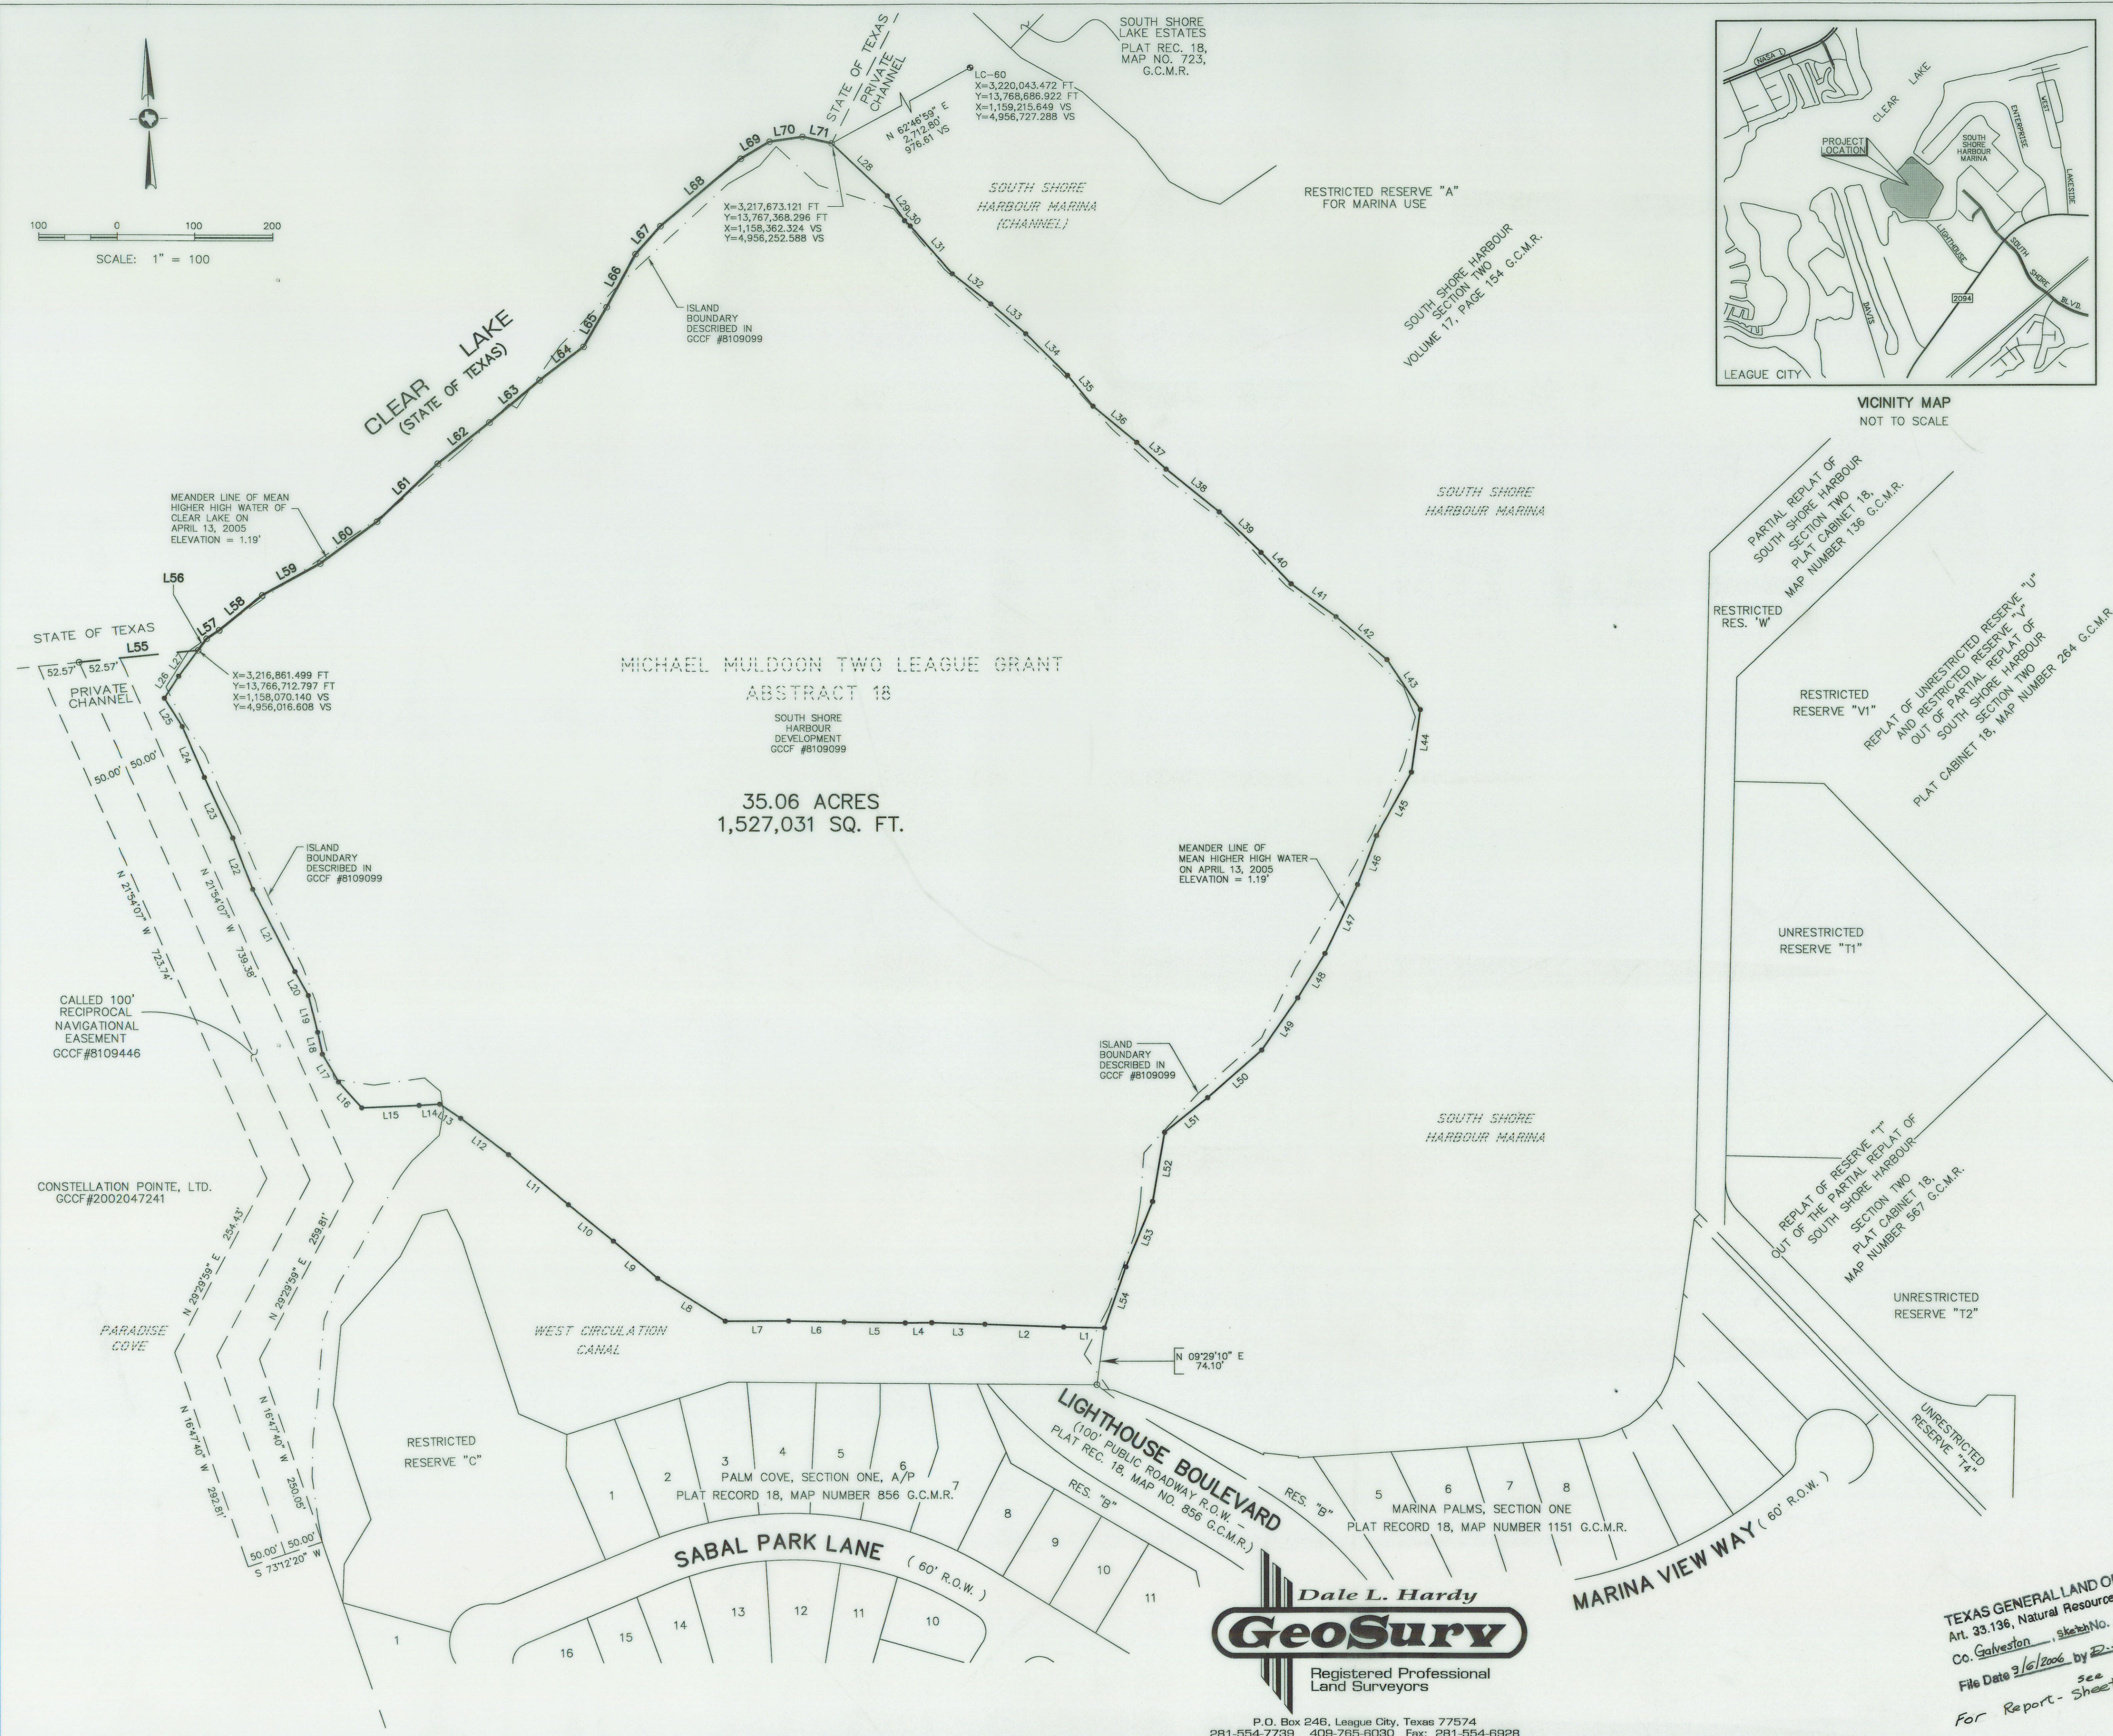
- This tract lies partially in Zone "X" (Unshaded), areas determined to be outside the 500-year flood plain, partially in Zone "X" (Shaded), areas of 500-year flood, and partially in Zone "AE", a special flood hazard area inundated by 100-year flood where base flood elevations have been determined (base flood elevation = 11'), as per the National Flood Insurance Program FIRM Community Panel Number 485488 0010, published revision dated September 22, 1999. Designations of solid flood zones were scaled from said FIRM and should be considered approximate.

- The upland portion of this tract adjoins and shares a common boundary with the tidally influenced submerged lands of the state. This tract may gain or lose portions of the tract because of changes in the boundary (i.e. erosion and/or accretion). State law prohibits the use, encumbrance, construction, or placing of any structure in, on, or over state-owned submerged lands below the applicable tide line, without proper permission. Any man-made alteration to this boundary line, i.e.: pier, bulkhead, dock or building construction or placement of fill material, requires approval and possible permitting from the Texas General Land Office, U. S. Corps of Engineers and any other governmental agency which has jurisdictional control over such matters.

I, William E. Merten, Licensed State Land Surveyor in and for the State of Texas, do hereby certify that on April 13, 2005, and May 11, 2005, I have located the natural contour line of Mean Higher High Water on the ground, according to law and with the personnel stated, and that the meanders of said contour line are true and correct as shown hereon. Concrete bulkheading, which is partially destroyed, is present along a portion of the frontage of the subject tract.
